An Aquatic Macroinvertebrate Bioassessment of the Pacolet River between Lake Blalock and Interstate I-85 (Spartanburg County, SC)

Bureau of Water
Aquatic Biology Section

Technical Report Number 8A19-11

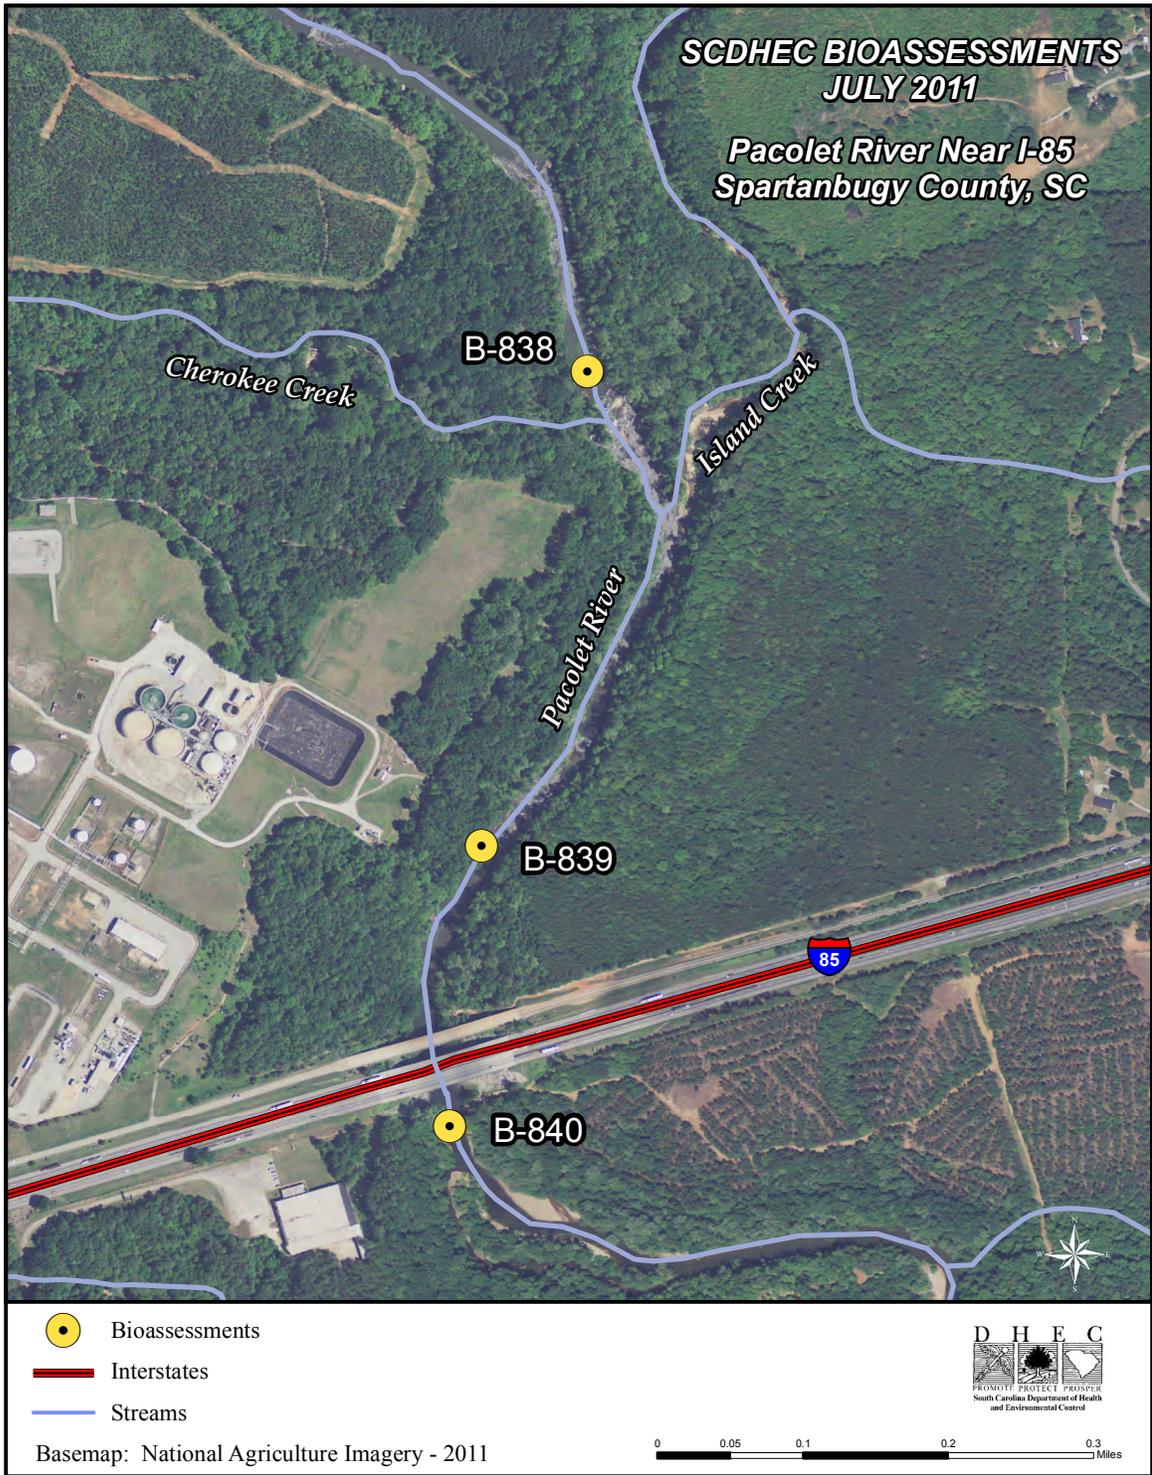
Figure 4. Pacolet River showing July 2011 SCDHEC Bioassessment locations.

For the Pacolet River study described here 3 locations on the river in the vicinity of the former Hoechst AG facility were selected for sampling (Figure 4 and Figures 6 - 8). Station B-838 was located above the confluence of Cherokee Creek and the Pacolet River and served as a control. Station B-839 was located below Cherokee Creek but above the current discharge point of Auriga Polymers NPDES discharge. The river here was directly adjacent to the facility property. Station B-840 was located below the I-85 bridge and was downriver of the former

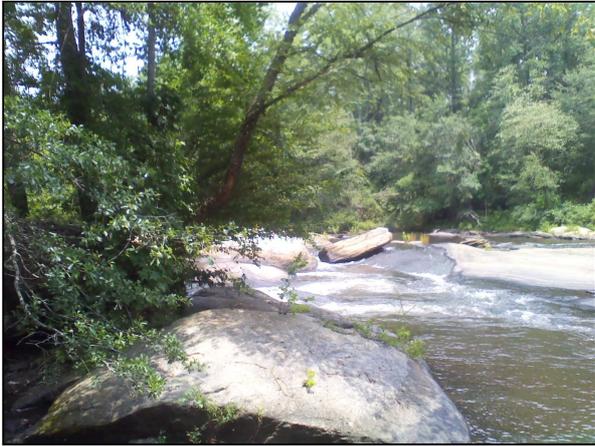
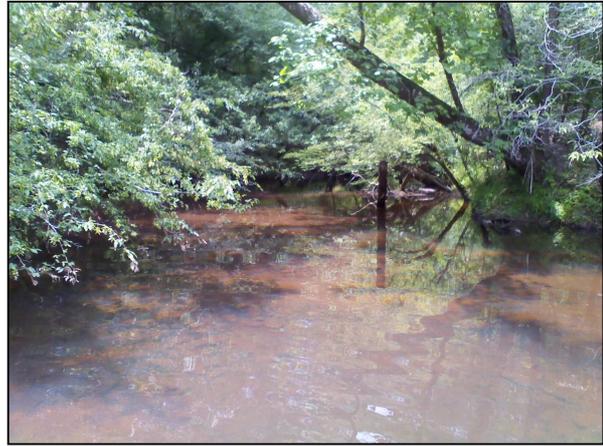
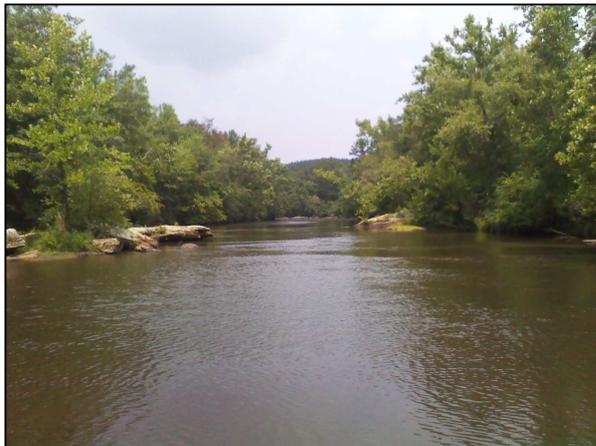
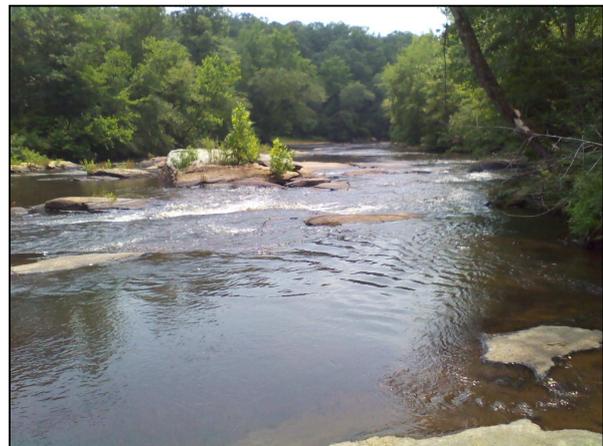
B

Description: Aesthetically the river at this location is more reminiscent of a remote waterway than one so near the urban center of Spartanburg. Graffiti on the boulders and the occasional piece of trash however indicated the river is in close proximity to development. And the highly eroded banks extending upwards in places for many meters betrayed the deforestation and agricultural activities that occurred in the piedmont of centuries past. This also served as a reminder of the oft-quoted passage of H.B.N. Hynes (1975) that "in every aspect, the valley rules the stream." Nevertheless the description by Simms (1844) over 150 years ago could still be applied today, at least to this section of the river: "Several beautiful cascades occur in these rivers. Those of the Pacolet are particularly so." Upriver toward the Blalock dam it appears from aerial photos that several of these cascades are present, interrupted by long stretches of runs containing occasional deep pools along the river margin.

Figure 6. Pacolet River near station B-838; A. Looking at shoals while standing at mouth of Cherokee Creek, B. Mouth of Cherokee Creek at the confluence with the Pacolet where pungent sediment odor was detected, C. S-838 in the Pacolet looking upriver, D. S-838 in the Pacolet looking down river

Station: B-838 (Figure 6)

Another observation we made was the detection of an extremely pungent odor at the mouth of Cherokee Creek in the sediments. Locating the river and the intended sampling site required us to park our vehicles on a dirt road on Auriga Polymers property and navigate through a wooded area until the river was located. This point was near the confluence of Island Creek, which was on the opposite shore of the Pacolet River. We walked upriver along the bank where we noticed the confluence of Cherokee Creek near a small island in the Pacolet River. We waded upriver along the west shore of the river to get around the island and above the confluence of Cherokee Creek. This portion of the river was a backwater area on the west side of the Island with slack water and deep sediment. It was here that, when the sediment was disturbed by our wading, the odor was detected. After sampling B-838, and as we returned to the vehicle, we investigated further and entered Cherokee Creek. Cherokee Creek at this point

widened where it joins the Pacolet. A cursory sample for macroinvertebrates was taken from the undercut banks and as we further disturbed the sediment the unfamiliar odor became extremely pungent. These findings were reported to other DHEC staff and sediment samples were collected in this area of the river and other parts of Cherokee Creek on 15 July 2011. These data will be reported in a separate document but initial results show the detection of various organic chemicals known to have been used by the Hoechst AG facility.

3. While conducting the 2011 investigation an extremely strong, unfamiliar chemical odor was detected in the sediment in a backwater area of the Pacolet River at the confluence of Cherokee Creek. Subsequent analysis at this site indicated the sediment is contaminated with various organic chemical compounds.

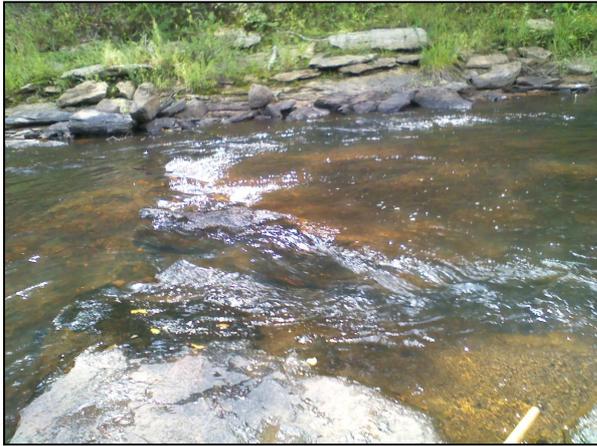
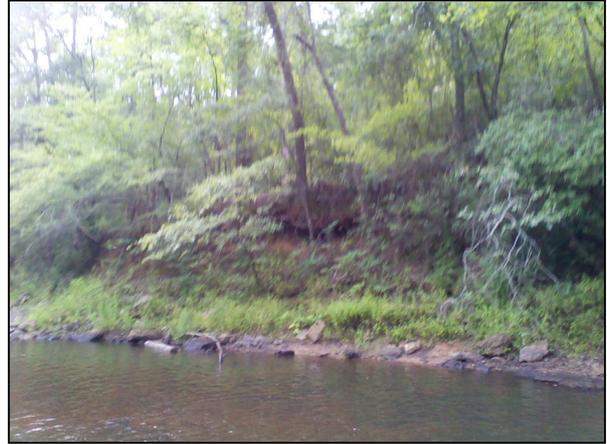
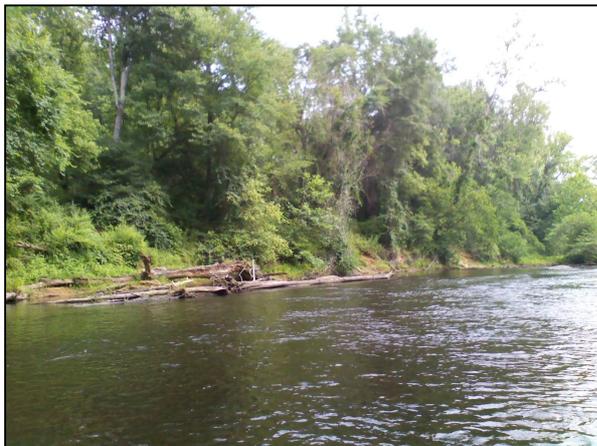
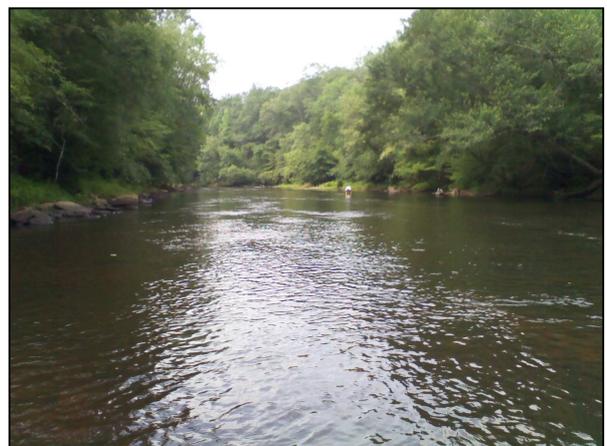
Description: The Pacolet River at this location consisted of a long run with water rolling over the numerous boulders and cobble. The cascades, near B-838, were absent at B-839 and the large pools at B-838 were not as abundant at B-839. Other aspects however, including the eroded yet heavily vegetated banks, were similar to the control site. The water was clear and had no unusual foam or smells at the time of sampling.

Figure 7. Pacolet River at B-839. A. Rock and cobble substrate in river; B Banks of river showing erosion; C. Banks eroded but heavily vegetated; D. Looking downriver.

Station: B-839 (Figure 7)

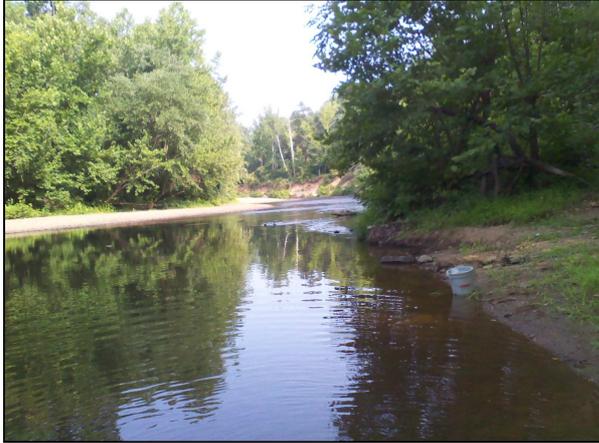
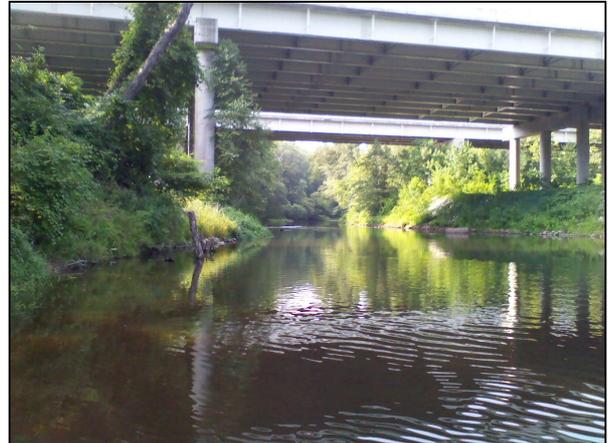
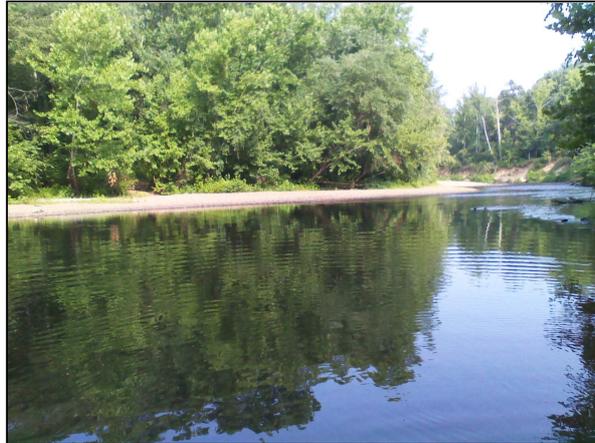
Description: The gradient of the Pacolet River was less here than the other two locations but the river was similar in many other aspects as the two locations upriver. The banks were more highly eroded and extremely large sandbars were

present along the east shore. But still, riparian vegetation was heavy on both shores except where the interstate crossed the river.

Figure 8. Pacolet River at B-840. A. Looking downriver showing high, eroded banks; B. Looking upriver toward I-85 crossing; C. Another downriver photo showing large sediment bar on opposite shore.

Station: B-840 (Figure 8)

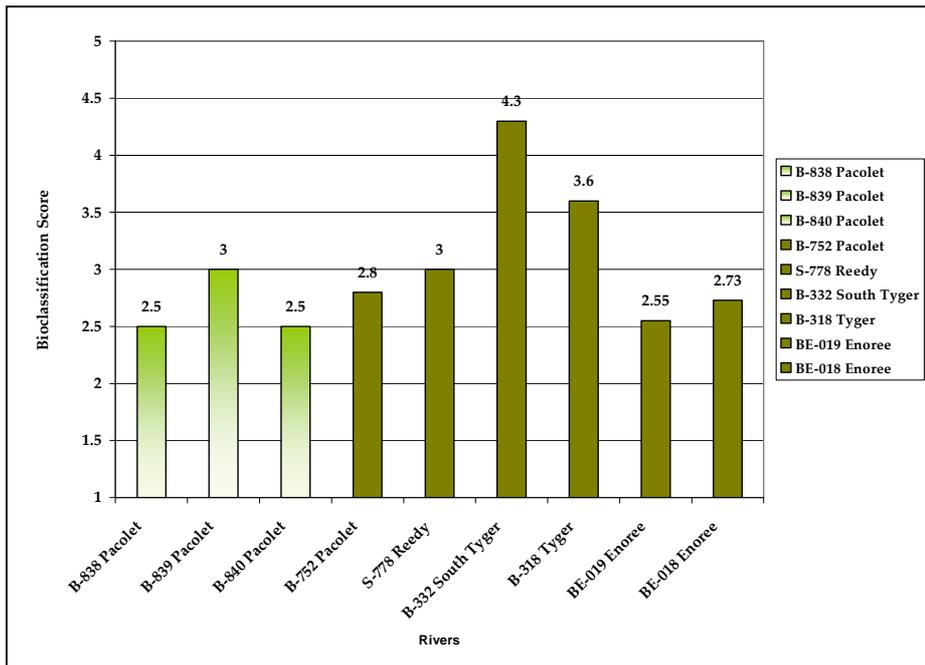
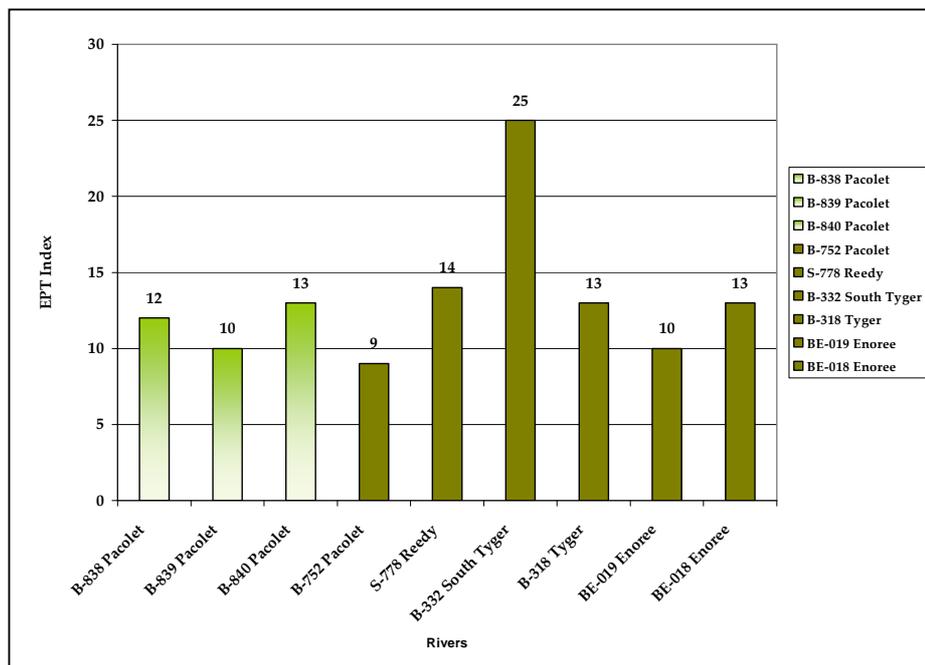
The macroinvertebrate bioassessment results are presented in Figure 9 and Appendix A. The aquatic macroinvertebrate communities at B-839 and B-840 were similar to B-838, the upriver control, with a bioclassification of Good/Fair at all three sites. This suggests that the former Hoechst AG property or the current Auriga Polymers Inc NPDES discharge are having little to no obvious impact on the macroinvertebrate community of the Pacolet River. Station B-839 had a slightly lower EPT Index than the upriver control and the overall abundance of organisms were noticeably depressed but this could have been due to natural variability. That the Pacolet River received a Good/Fair rating rather than a Good or Excellent that was found in the upper watershed was not unexpected, because of the two large dams that occur in the rivers. Scientist have known for some time that the damming of rivers can have deleterious effects on aquatic communities downriver of the reservoir (see Poff et al. 1997) and that appears to be the case here.

Figure 9. Bar charts comparing 2011 Pacolet River results with historic data from other piedmont rivers. A. Bioassessment Scores; B. EPT Index.

1. The Bioclassification and Bioclassification Scores at B-839 (Good/Fair 3.0) and B-840 (Good/Fair 2.5) were comparable to the upriver control site of B-838 (Good/Fair; 2.5), suggesting no obvious impact to the rivers macroinvertebrate community from the former Hoechst AG facility or the current Aurega Polymers NPDES discharge.

2. The Bioclassification of Good/Fair was comparable to historic data from the Pacolet River near the Broad River confluence (B-752, Good/Fair, 2.8); the Enoree River at secondary road 75 (BE-018, Good/Fair, 2.73 mean); the Enoree River at SC Hwy 418 (BE-019, Good/Fair, 2.55 mean); and the Reedy River at secondary road 68 (S-778, Good/Fair, 3.0 mean) but lower than the Tyger River at SC Highway 56 (B-318, Good, 3.6 mean) and the South Tyger River at secondary road 86 (B-332, Good, 4.3 mean).
