SAND SCRAPING AND TRANSFERS ALONG SEABROOK ISLAND

SUPPLEMENTARY REPORT REVIEW & ANALYSIS OF ALTERNATIVES

Coastal Science & Engineering Inc (CSE)
PO Box 8056, Columbia SC 29202-8056

[2534-SR]
MAY 2022

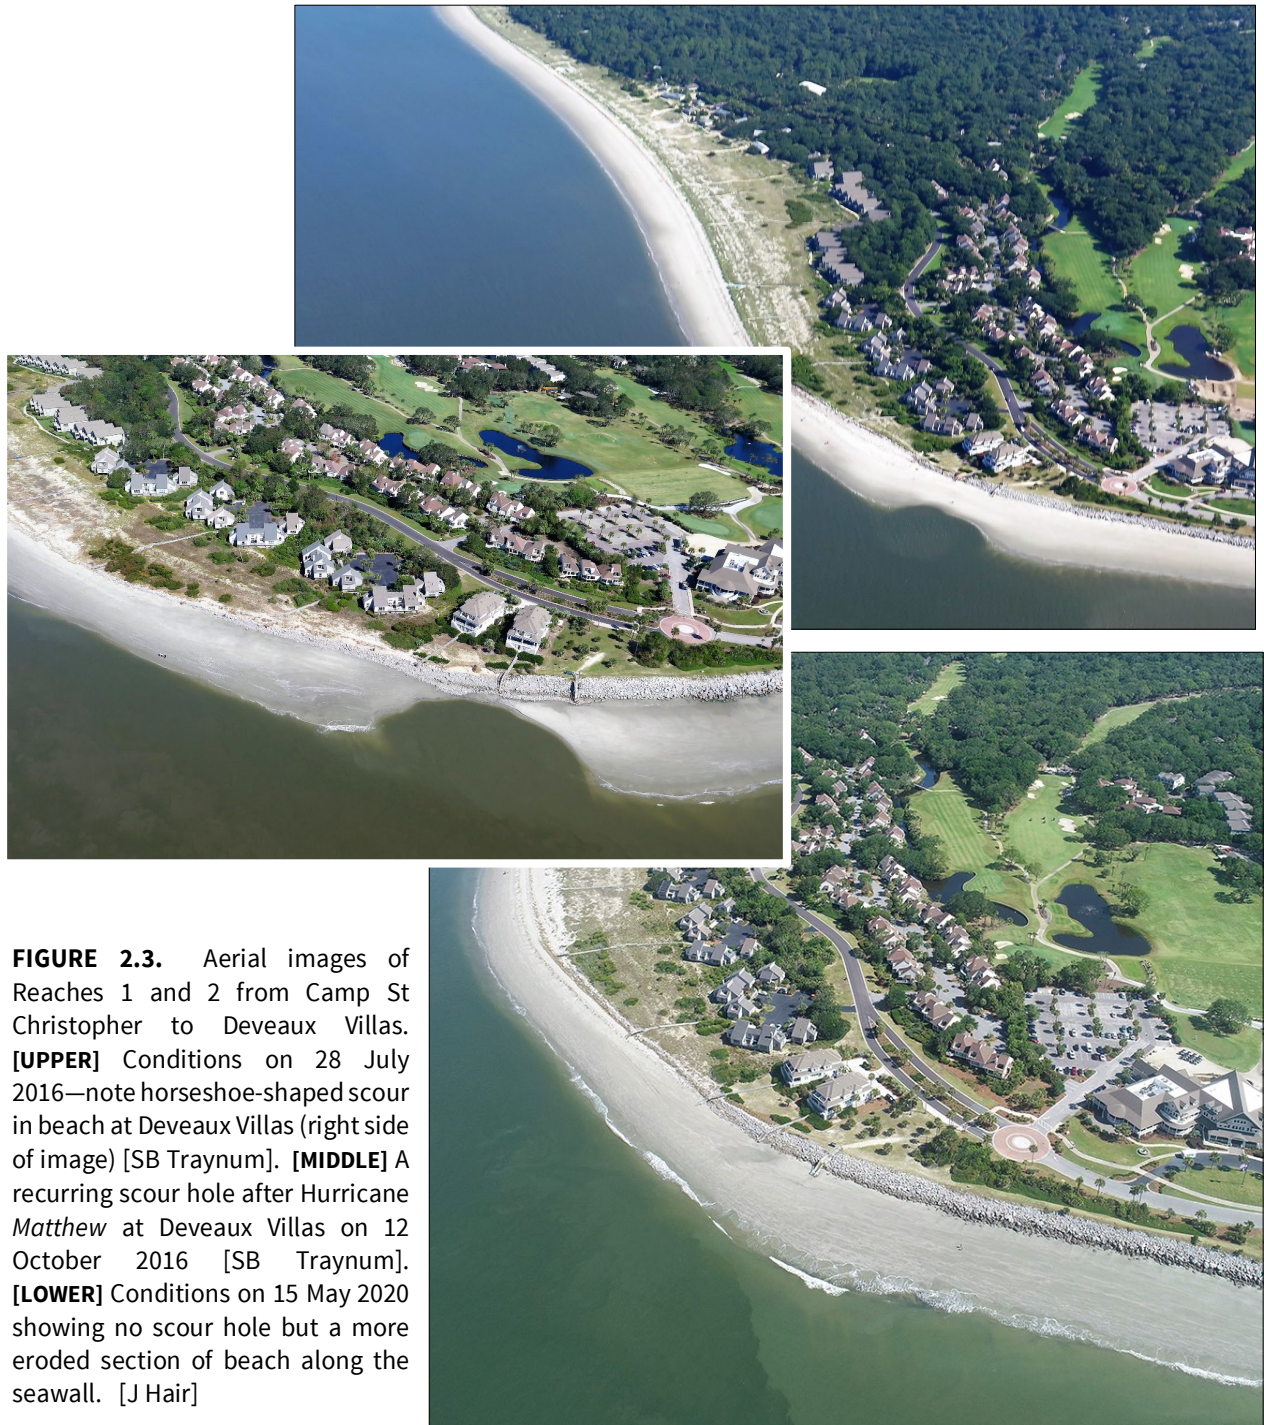
FIGURE 2.3. Aerial images of Reaches 1 and 2 from Camp St Christopher to Deveaux Villas. **[UPPER]** Conditions on 28 July 2016—note horseshoe-shaped scour in beach at Deveaux Villas (right side of image) [SB Traynum]. **[MIDDLE]** A recurring scour hole after Hurricane *Matthew* at Deveaux Villas on 12 October 2016 [SB Traynum]. **[LOWER]** Conditions on 15 May 2020 showing no scour hole but a more eroded section of beach along the seawall. [J Hair]

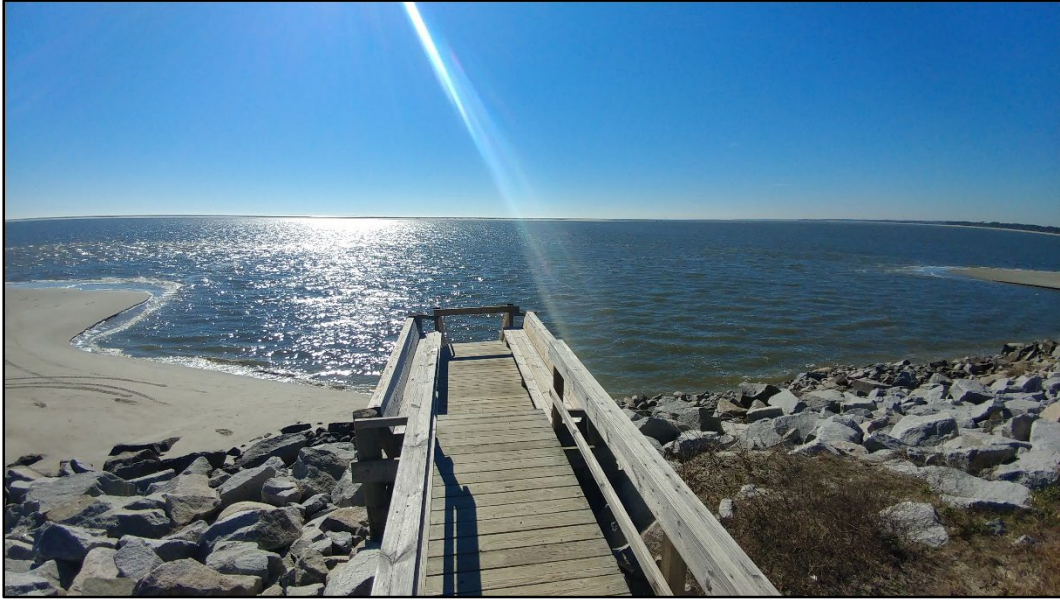
FIGURE 2.4. [UPPER] Ground image of the scour-hole event on 25 January 2017 viewed from the community boardwalk next to Deveaux Villas (D Giles). [LOWER] Orthorectified mosaic of drone images of the third scour hole obtained at low tide on 27 January 2017 (D Giles).

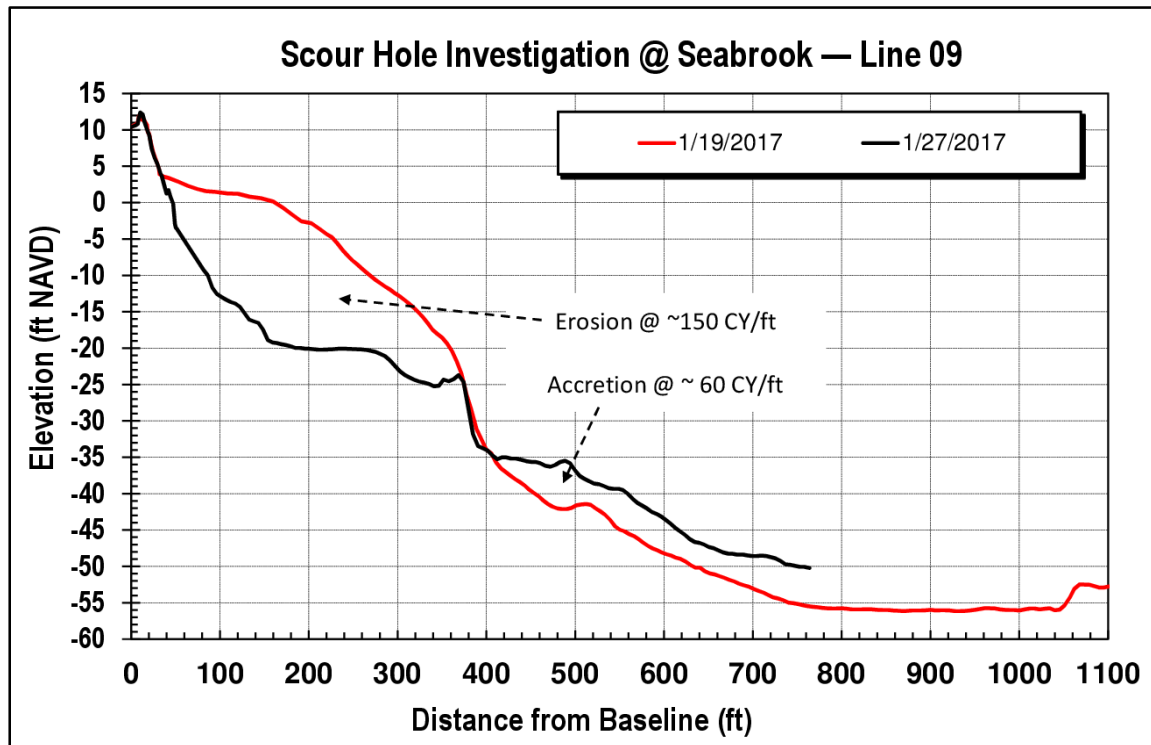
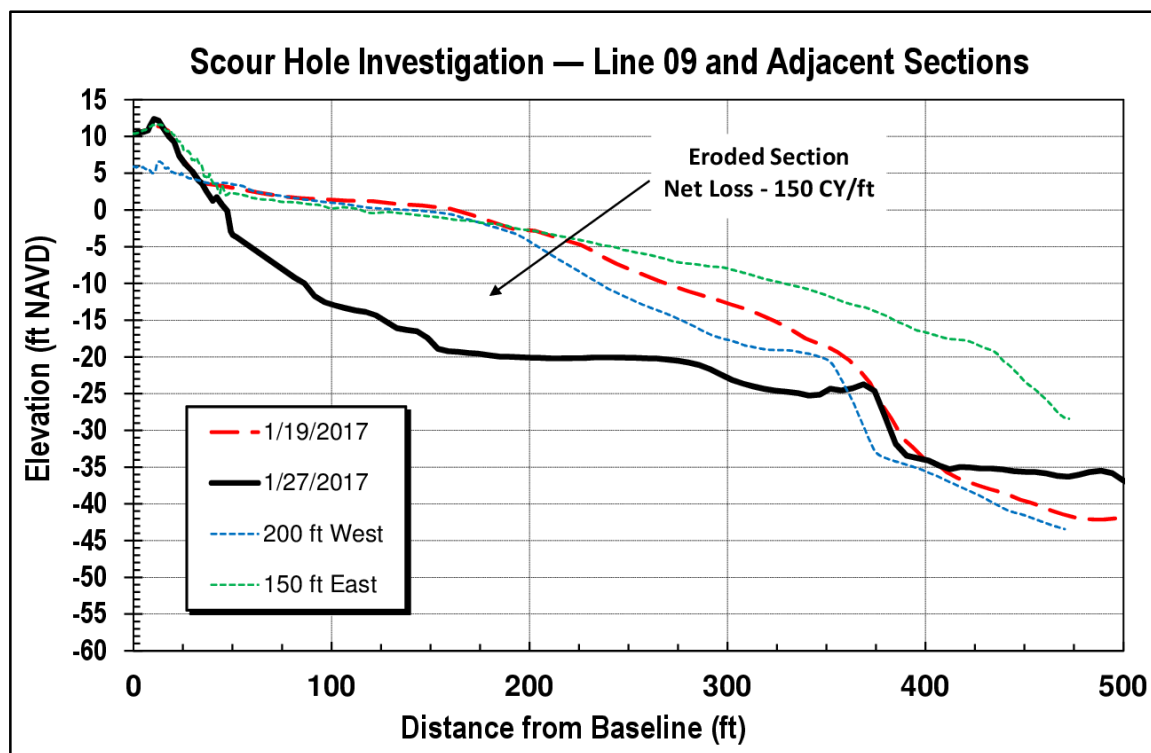
FIGURE 2.5. Representative profiles obtained on 19 and 27 January 2017 before and after formation of the third scour hole. Profile 9 shows extensive sand loss above the 25-ft depth contour and buildup along the margin of the inlet channel between 35 ft and 55 ft depths. The zone between 25 ft and 35 ft did not change, presumably because this area consists of denser consolidated sediments that hold the inlet in place (Moslow 1980, Imperato et al 1988).

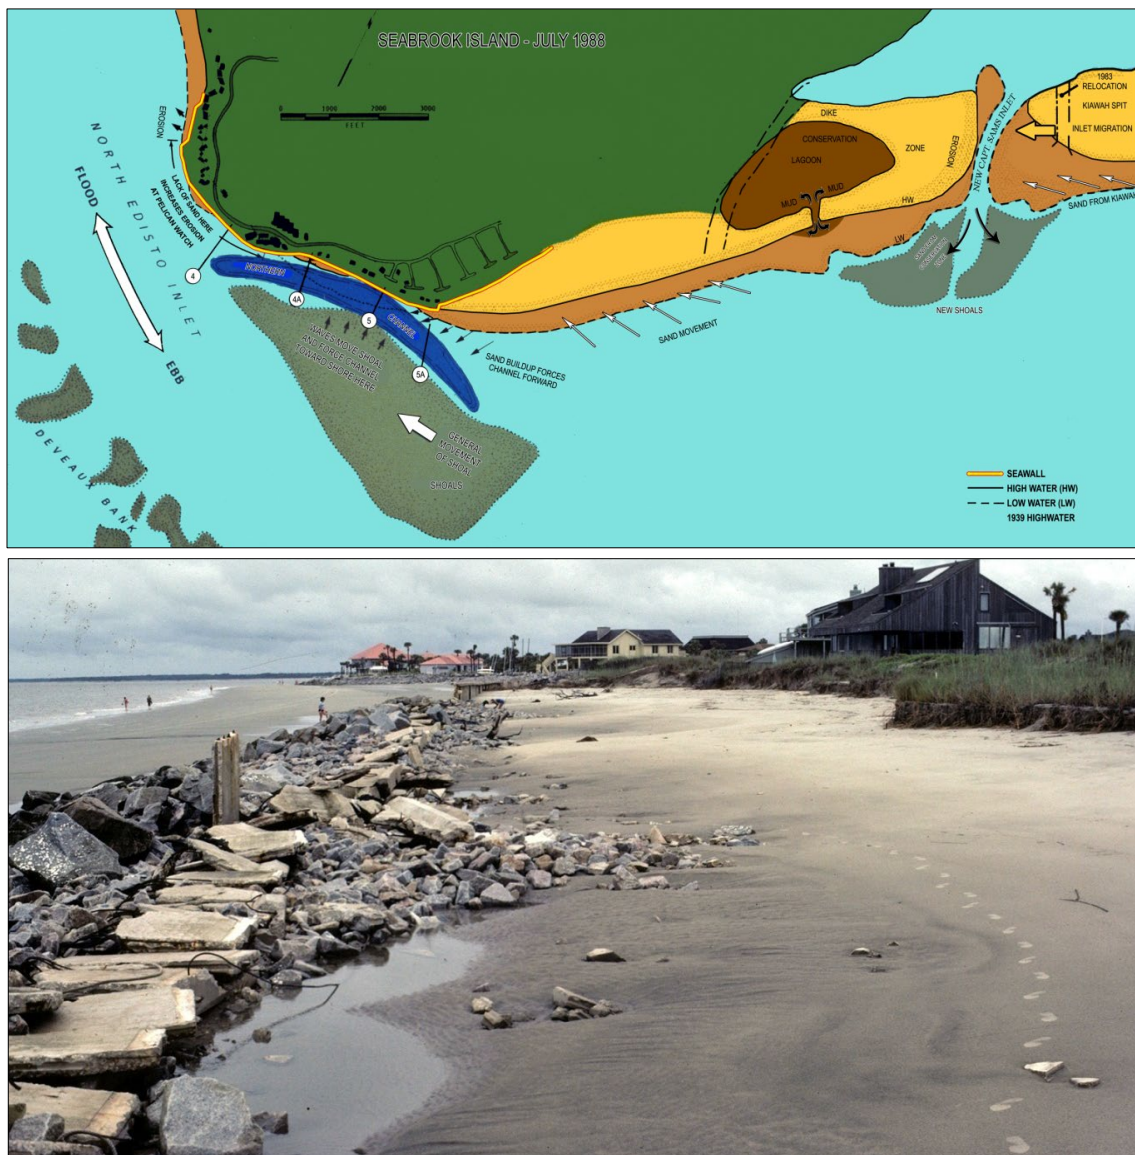
FIGURE 2.7. Conditions along Seabrook Island around 1989 (upper) when the north shoal of North Edisto River Inlet forced the Northern Channel into the seawall and eliminated the wet-sand beach, inhibiting longshore transport to downcoast areas. The lower diagram shows a collapse of the seawall in 1983 in Reach 5.

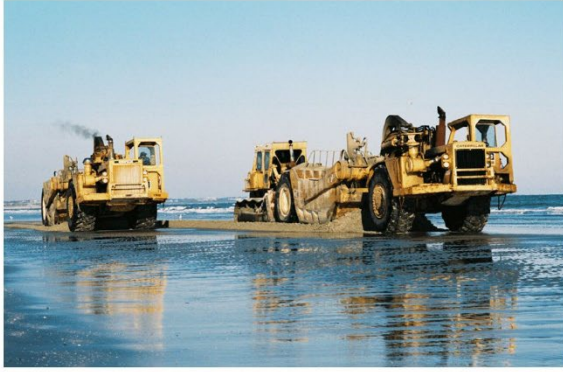
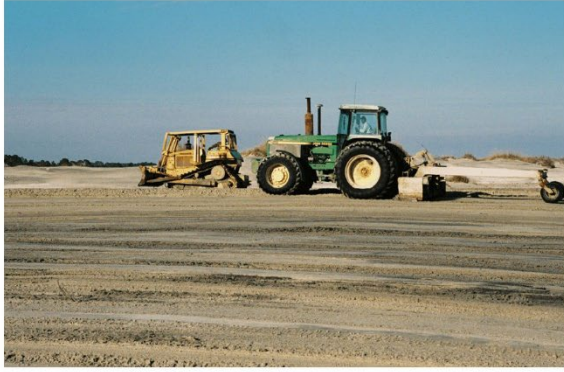
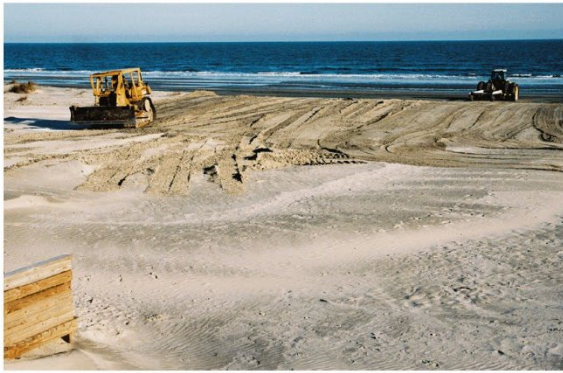
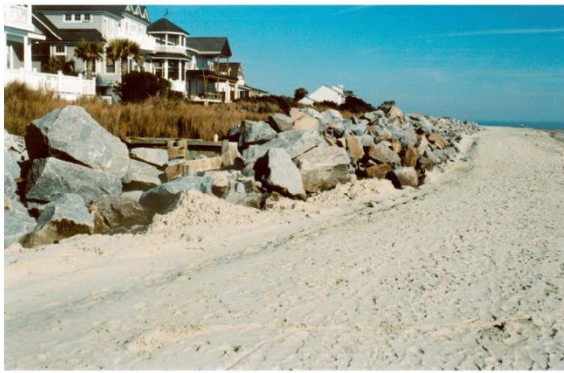
FIGURE 2.10. Photos of the 2004-2005 sand scraping and transfer project. **[UPPER LEFT]** Pan earthmovers loading sand from North Beach at low tide. **[UPPER RIGHT]** A bulldozer and farm tractor with scraper blade grading and dressing the beach. **[LOWER LEFT]** Regrading and dressing slopes around Oystercatcher beach access. **[LOWER RIGHT]** Scraped sand in place against the seawall around Beach

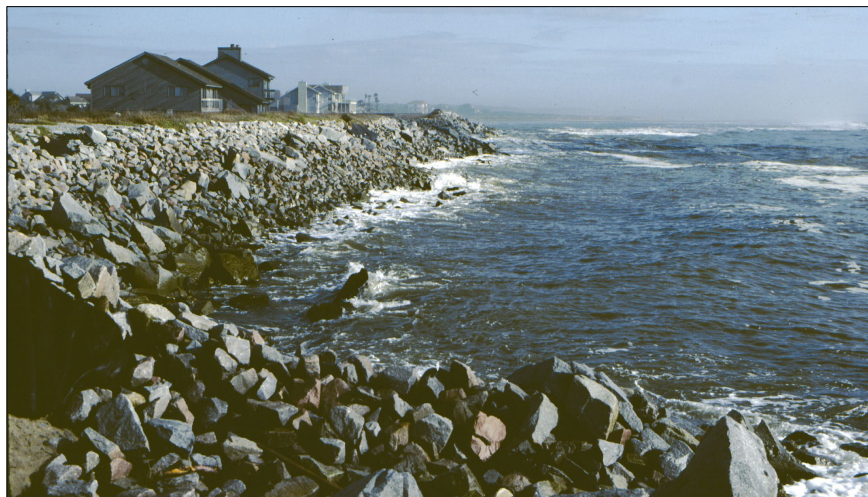
FIGURE 3.2. Beach erosion in reaches 6 and 7 (see Fig 1.1) led to exposed seawalls, no recreational beach, and severe damage to structures in 1983. View north along Reach 7 in 1985 at low tide. [After CSE 1989]

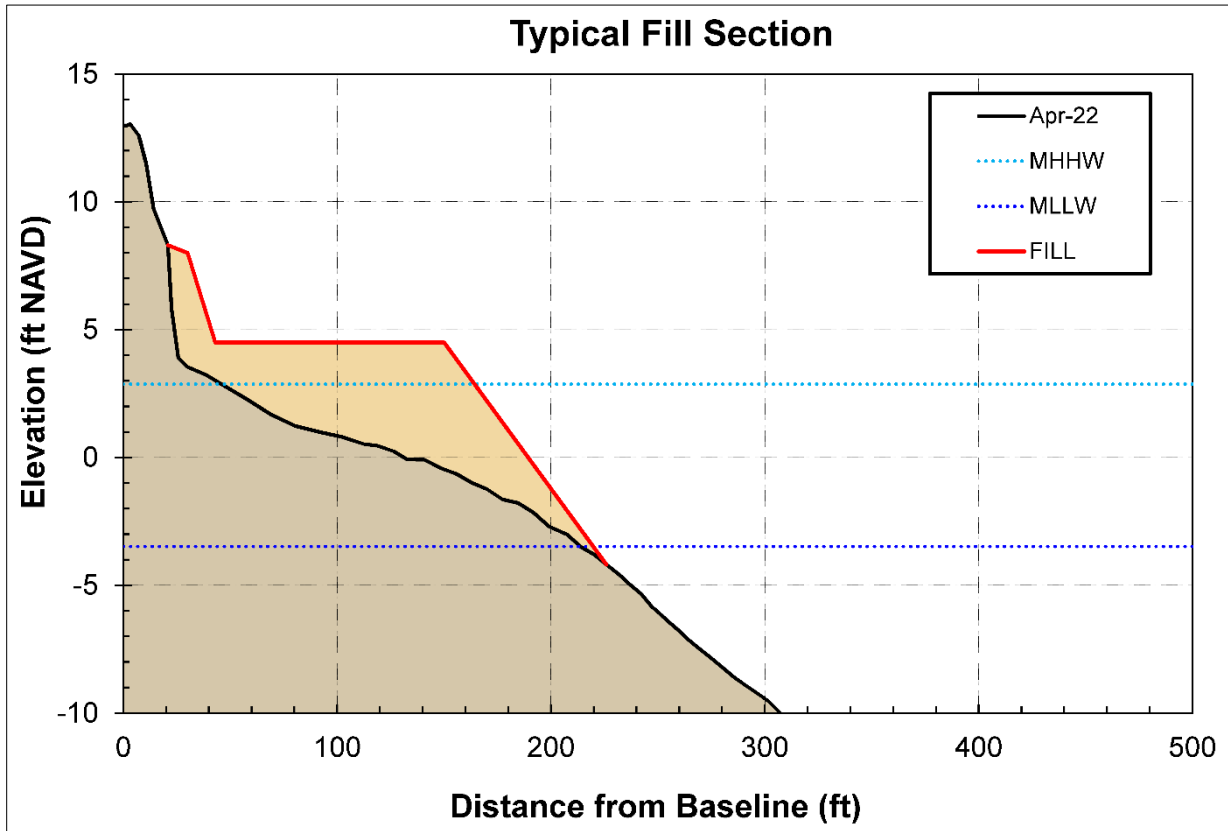
FIGURE 3.3. Typical excavation and fill sections for the proposed project to be performed in the dry via land-based equipment working around low tide. Excavations of the wet-sand beach would be shallow and expected to heal quickly under daily tidal action.

All work under this alternative could be performed above water levels working along the wet sand beach to minimize impacts to dry beach habitat. As the project progresses, the area of dry beach would expand and exposure of the seawall would decline. The proposed borrow area would likely be restored naturally as shallow water bars from the migrating delta of Captain Sams Inlet shift downcoast into the project area. This, in turn, would help maintain the ephemeral washover habitat upcoast of the borrow area.

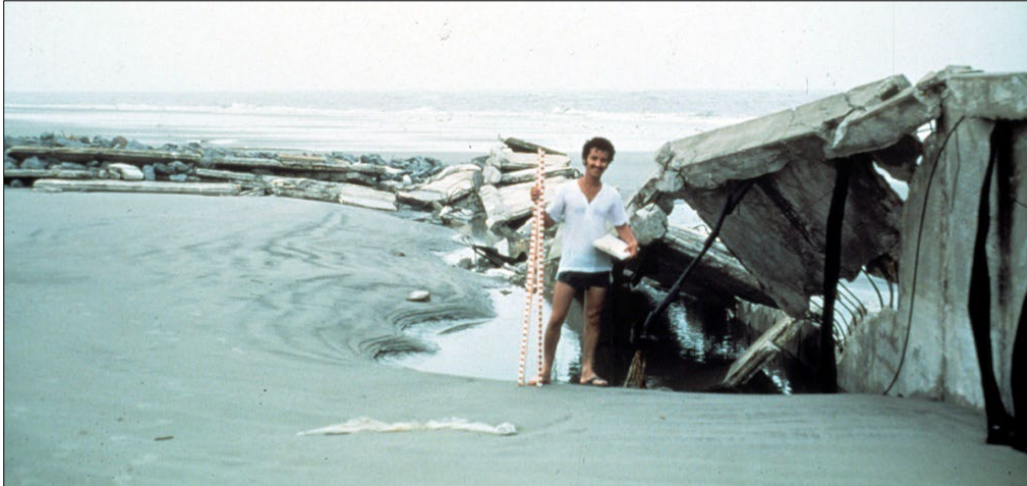
FIGURE 3.4. Concrete sheet pile seawalls were installed along portions of reaches 5 and 6 in the 1970s. As they became more exposed, rip rap and larger armor stone was added for reinforcement and scour protection. Image shows a section of the concrete seawall after a collapse during Hurricane *David* (September 1979). [Source photo by Research Planning Institute Inc.]

Much of Seabrook Island is protected by an ~8,500 ft seawall, which includes sections of concrete sheet pile (Figure 3.4) underlying large quarry stone, as well as timber bulkhead structures along the North Edisto River Inlet shoreline. Approximately 70% of the seawall is presently buried and protected by a dry-sand beach and incipient foredune (Figure 3.5). Sections lacking dry beach protection are vulnerable to direct wave action, runup, and overtopping. As some sections become increasingly exposed, concomitant with a lower wet-sand beach, wave forces exceed the design of the structure. The crest of the seawall and the size of individual armor stones are inadequate for such conditions along the critically eroded sections between the Beach Club and Beach Club Villas (Figure 3.6). The applicant considered reinforcing the seawall at the most vulnerable sections, but rejected this alternative for several reasons.

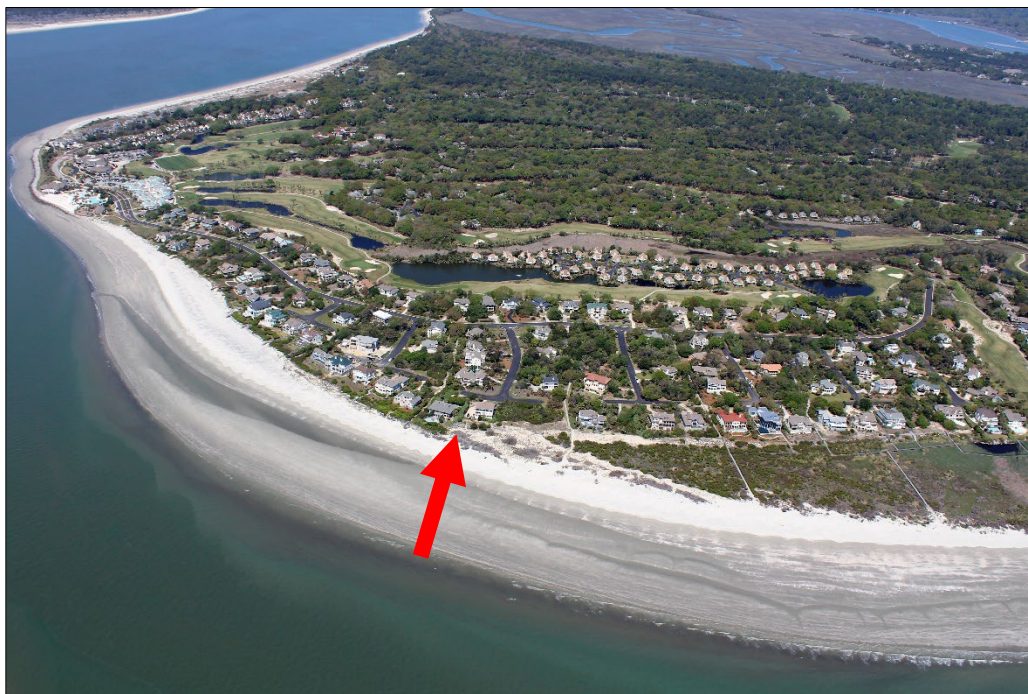
FIGURE 3.5. Reaches 4, 5, and 6 along Seabrook Island are armored by a quarry stone seawall that is now buried by sand transported south from Capt Sams Inlet by natural, as well as, artificial means. Arrow marks the location of Fig 3.4 where the 1970s seawall has been completely buried under a vegetated dune. [Image by SB Traynum – CSE on 11 April 2018]

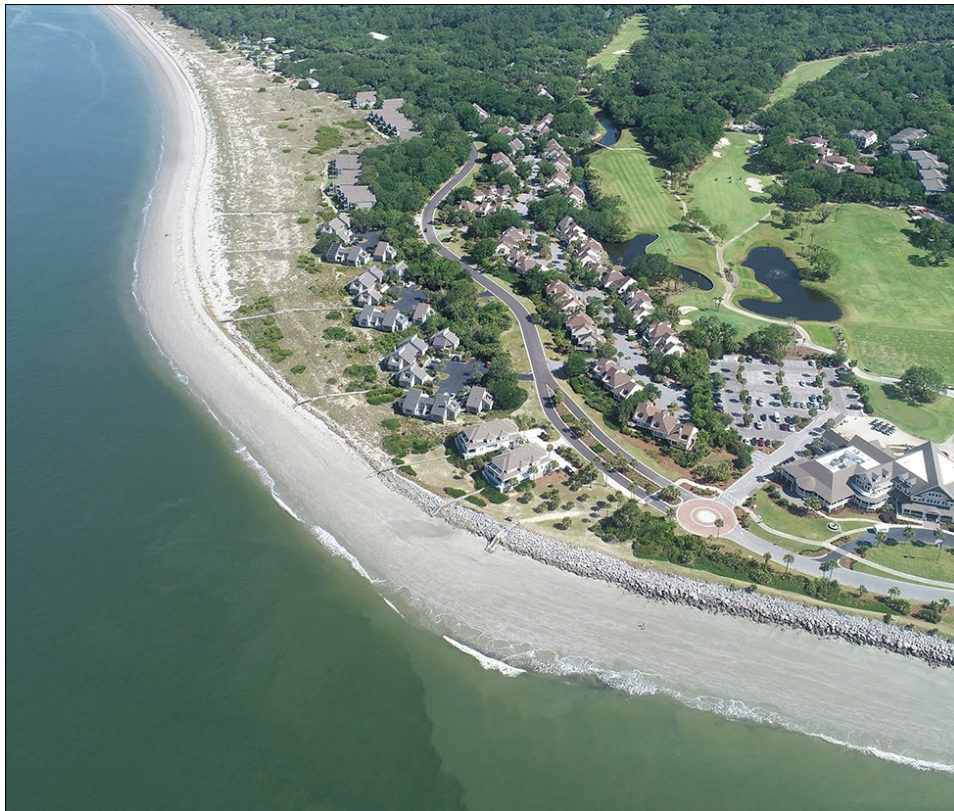
FIGURE 3.6. Section of exposed seawall in the critically eroded Reach 3 on 15 May 2020. The crest elevation of the wall is lower and the armor stone is smaller in front of the homes in the image. This is considered the most vulnerable section of the beach at present. [Photo by J. Hair – CSE]

Presently, the most vulnerable section of seawall in the vicinity of repeated scour and slumped beach areas has a lower crest elevation and smaller-sized armor stone than the immediate upcoast area (see Figure 3.6). This section is considered the most vulnerable to catastrophic failure at present. Some repairs consistent with BMA rules have been made to this section of the wall, but these remain insufficient to prevent a future collapse. Much more armor stone using larger units would be required to provide long-term protection if the beach continues to erode. The crest would have to be raised by 3–4 ft, consistent with upcoast sections around the Beach Club, and armor stone would have to extend underwater down the channel slope. Such repairs and upgrades would be comparable in cost to the Preferred Alternative but would not maintain a viable beach. Such a structure would likely impede sand transport to downcoast areas because it would eliminate a critical section of wet-sand beach over which sand is transported from upcoast to downcoast areas by breaking waves.

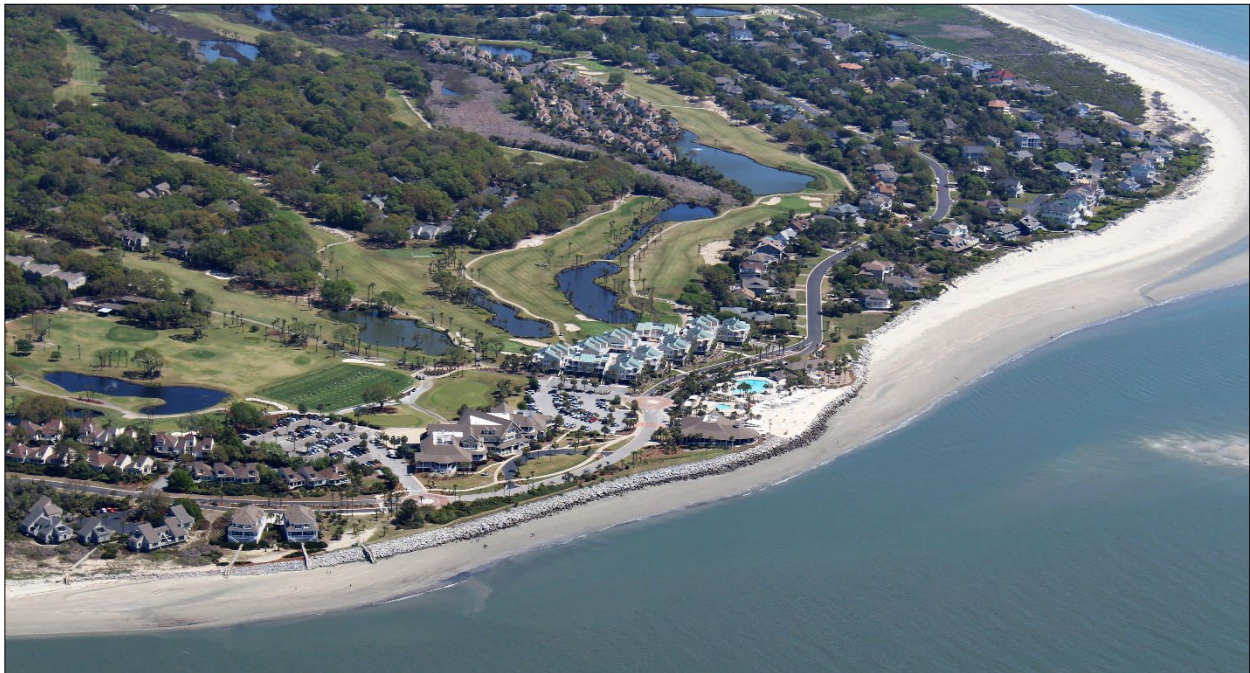
FIGURE 3.7. Section of exposed seawall on 11 April 2018. Oceanfront properties (11) visible at lower left corner of the image have a present Zillow value of ~\$21 million. The Beach Club complex (center of image) is estimated to have a comparable value. Buyouts and relocation of these properties was considered but rejected by the applicant based on cost and potential for litigation.

The applicant considered selective abandonment and relocation of vulnerable properties, particularly the buildings behind exposed sections of the seawall illustrated in Figure 3.7. This solution would also incorporate realignment of the seawall in a more landward position to enhance beach recovery. The present Zillow value of oceanfront properties shown in Figure 3.7 is ~\$21 million. The Beach Club buildings and pools are assumed to be valued similarly. Abandonment or relocation of the most vulnerable properties would therefore cost 30-40 times the Preferred Alternative before considering the potential costs of seawall realignment and the likely high cost of litigation associated with any property condemnation.
