Subject Line: Laurens Data Gap Investigation Results Meeting Summary

3M LAURENS

Investigation Summary and Path Forward

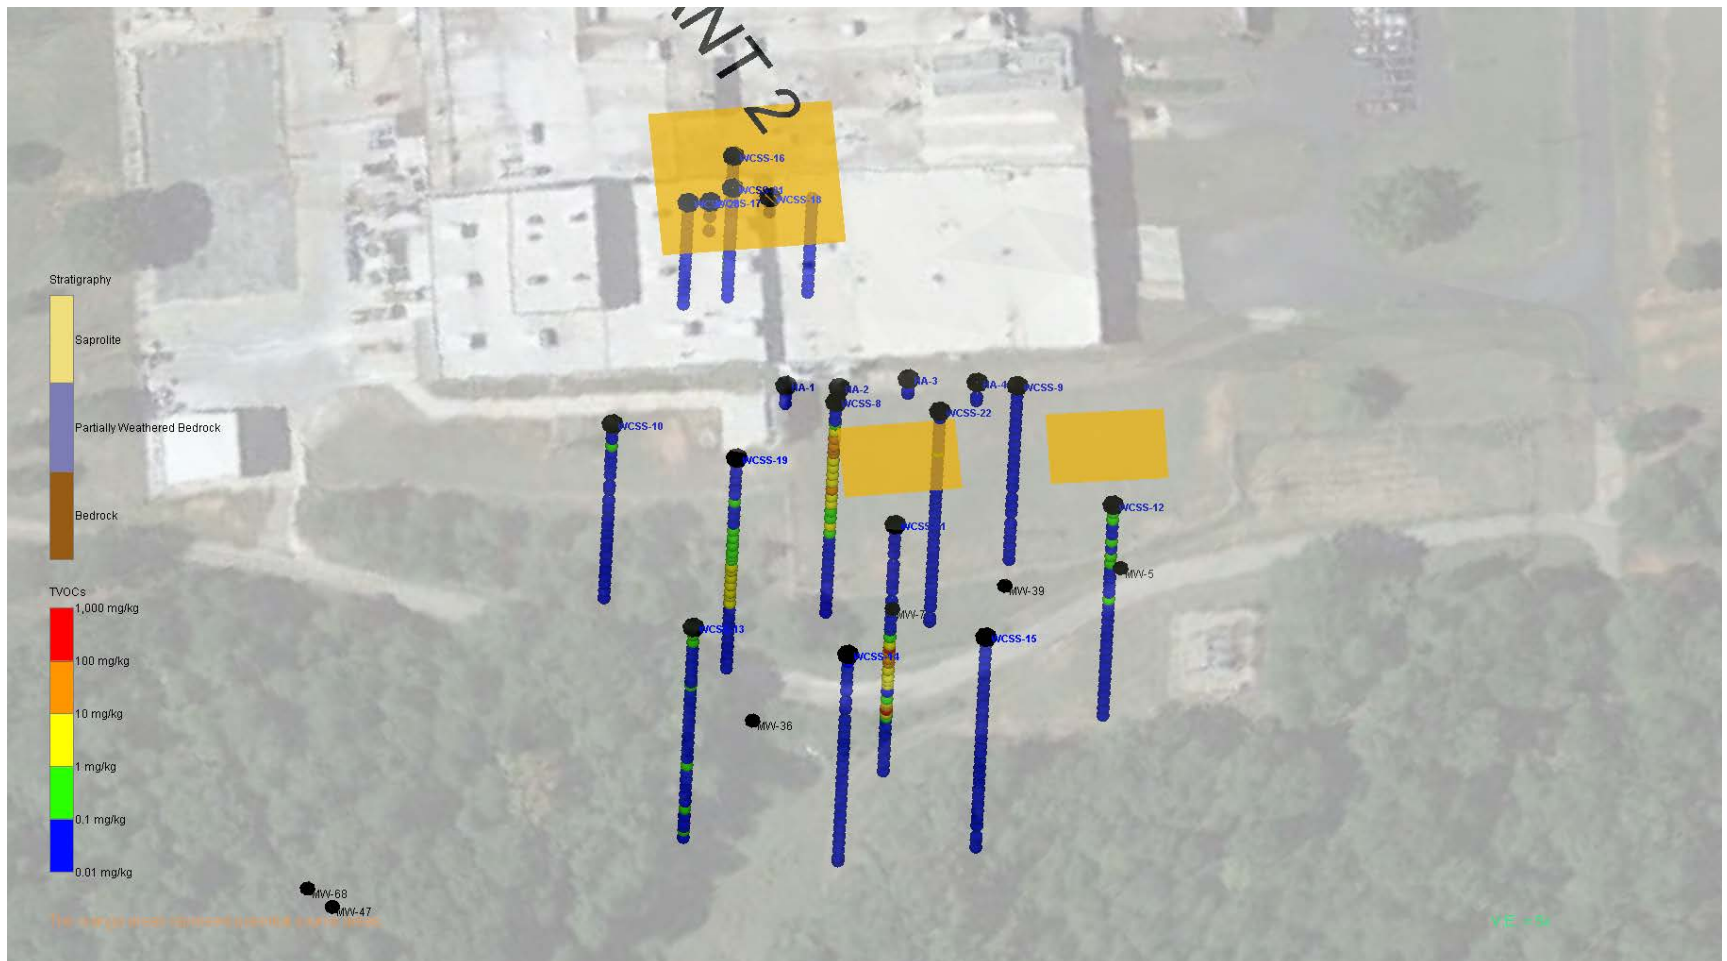
Plant 2 Results (TVOCs)

- Identified COCs
 - PCE, TCE and associated daughter products
- Source identified upgradient of the ponds, near the eastern exterior wall of Plant 2, near WCSS-8
- No source area identified beneath Plant 2
- Former Plant 2 Ponds not identified as a source
- COCs identified in saprolite with discharge to underlying PWR
- COC concentrations reduced along transport pathway, daughter products evident
- Identified source areas are consistent with observed dissolved-phase plume in historical monitoring well and surface water sampling network
