# South Carolina

## Annual State of the Beaches Report

2009

Ocean and Coastal  
Resource Management

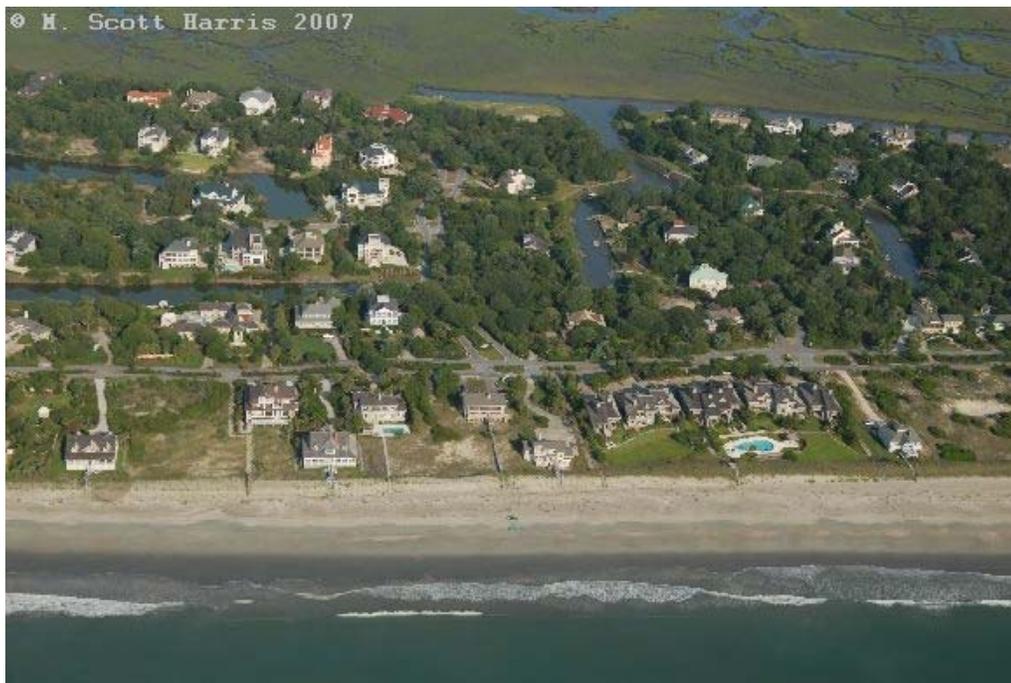
Station 4140, near the northern end of the bulkhead, is the “pivot point” on Debidue—the beach typically erodes to the south and accretes to the north. During the previous year this station saw erosion between the +7 ft and –2 ft contours, as the beach cut back by up to 25 ft. The renourishment project added approximately 200 ft of beach to the profile with approximately 68 cubic yards of fill material per foot of beach. Between June 2006 and May 2007, 70 ft of beach have been lost and the profile steepened, while the recent survey period showed a slight gain in backbeach elevation and landward movement of the berm by about 10 ft. A similar loss is noted at station 4150.

**Figure 24. Aerial photograph of Debidue Beach near station 4130.**

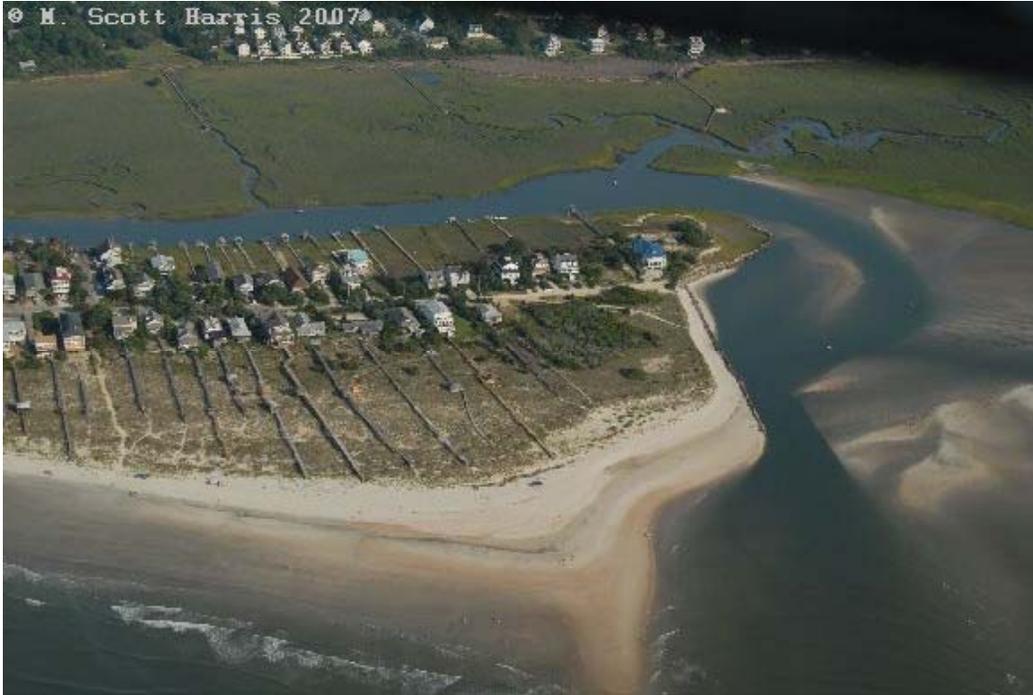
**Figure 27. Northern end of Pawleys Island. A bar has migrated onto the island here (Photo Credit: Scott Harris, June 22, 2007).**

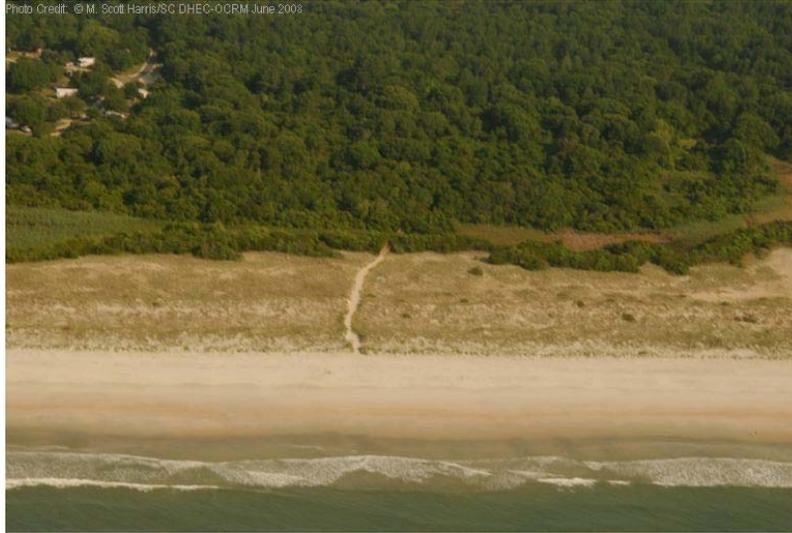
As proximity to Murrells Inlet increases the primary dune becomes somewhat smaller and the shoreline can become more dynamic, although the inlet itself is stabilized by jetties that were constructed in the early 1980's. At station 4535, a small dune formed 25 ft seaward of the 2005 position and increased in size between 2007 and 2008; however the profile exhibited slight erosion from +5 ft to 0 ft and eroded 5 ft in elevation below -5 ft, contributing to a steepening of the profile. Station 4545 experienced similar erosion of the upper shoreface with a slight increase in elevation of the primary dune and erosion at the dune toe. Stations 4555 and 4565 were more dynamic, experiencing erosion from the seaward dune face down to the -5 ft contour and movement of the dune approximately 10 ft landward. The 2007 dune has been removed, stepping the upper beach landward approximately 50 ft, and the wide beach below 0 ft has eroded downward two to three ft in elevation down to -7 ft.

**Figure 31. Aerial photograph of Huntington Beach State Park. (Photo Credit Scott Harris and DHEC, June 25, 2008)**

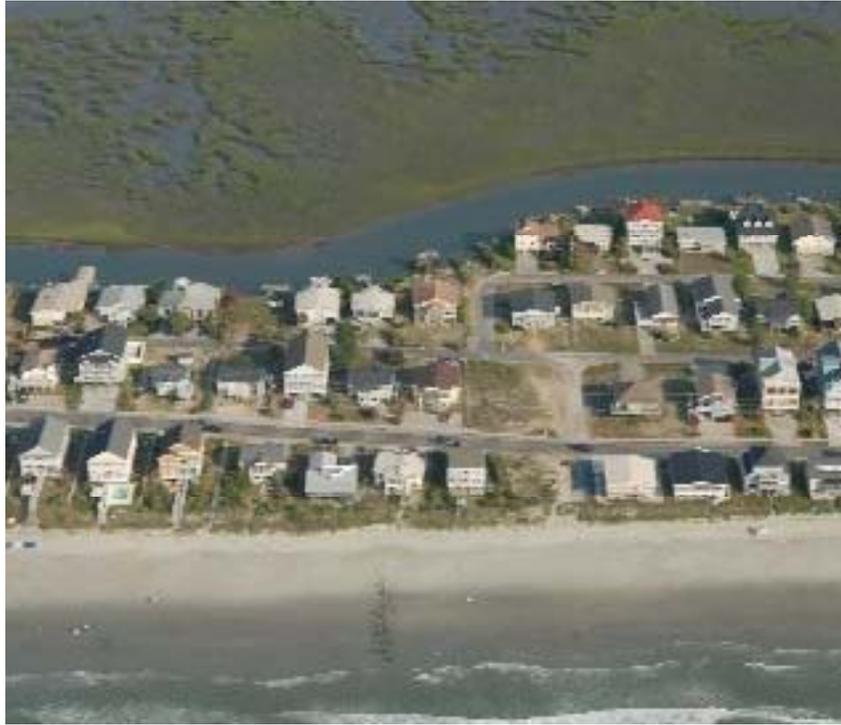
Stations 5005 to 5035, the northernmost section of Garden City in Horry County from the pier to Melody Lane, are mostly armored and lack a dune but have a minimal dry-sand beach. Prior to the 1998 renourishment project this area had a substantial sediment deficit, and the renourishment has not performed as well here. Between May 2004 and April 2006 stations 5005 through 5035 showed significant erosion on the upper beach between the 5 and 0 ft contours. Accretion from 2006 to 2007 has slowed, with erosion between 0 and -5 ft, and a slight accretion from 0 to +3 ft. Just north of here all

stations showed a continued loss of the renourishment berm, now only 40 ft wide in places, and also erosion along the entire profile out to a depth of -10 ft.

**Figure 33. Aerial photograph of Garden City near Station 4970. (Photo Credit Scott Harris, June 22, 2007)**

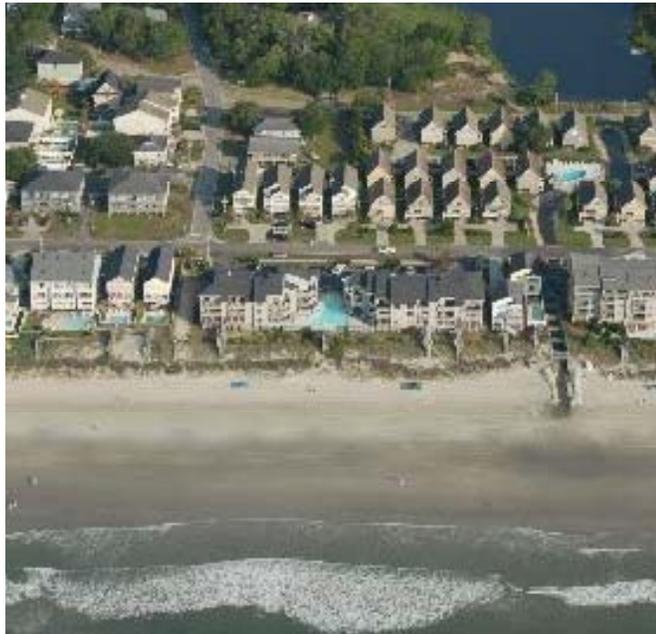
**Figure 36. Aerial photograph of northern Surfside Beach. (Photo Credit Scott Harris, June 22, 2007)**

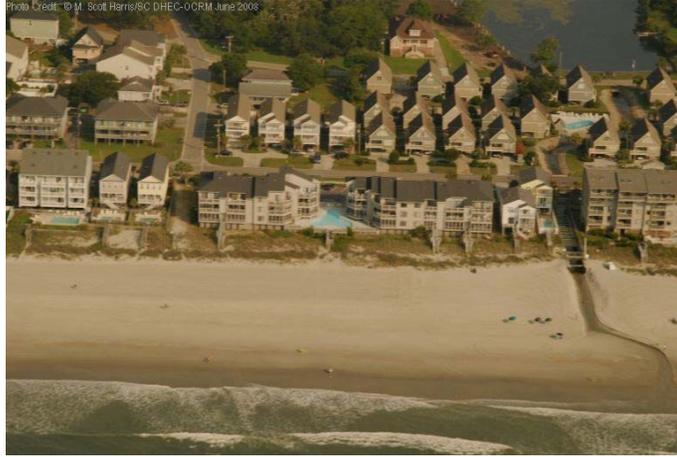
**Figure 37. Aerial photograph of northern Surfside Beach. Notice the change in width of the upper beach due to renourishment (photo credit Scott Harris and DHEC, June 25, 2008).**

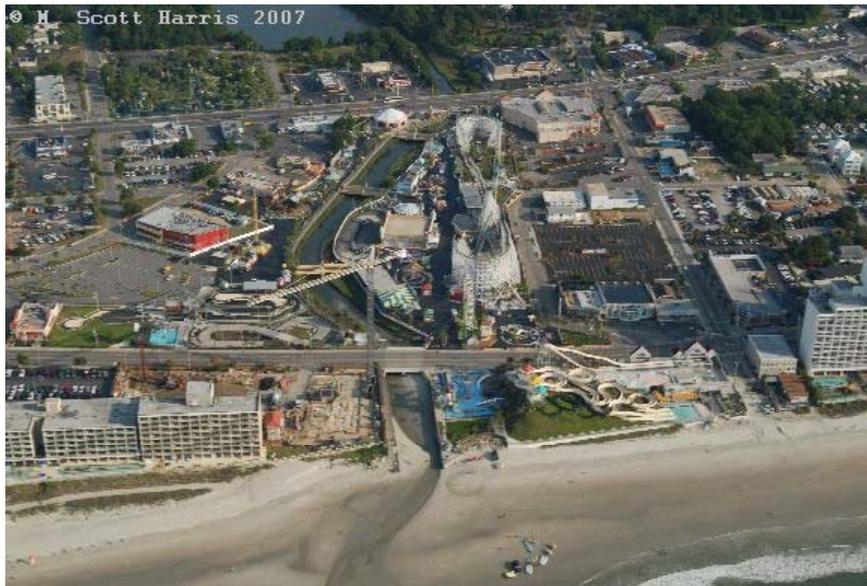
**Figure 39. Withers Swash in Myrtle Beach near station 5350.**

Stations 5300-5430, from 29<sup>th</sup> Ave. South to 31<sup>st</sup> Ave. North, are located in the southern commercial district. There are many seawalls and bulkheads in this region, and before renourishment sand volumes were relatively low. The 1997 renourishment project stabilized by 2000 and the upper beach berm has lost only a minor amount of sand since then. During the 2007 survey period almost all stations showed erosion from February to November from 0 to +5 ft countered by accretion farther up the profile from +5 to +10 ft in the upper beach and almost all stations showed accretion on the upper beach as the berm increased in width and also grew vertically by 1 to 2 ft. Between 2007 and the current survey period, the renourishment project added to the berm by 25 to 50 ft at +5 ft. Lower in the beach profiles, loss was seen from 0 to -5 ft in response to the increased beach slope. Below the stations in the southern section of Myrtle Beach, from 5300 at 29<sup>th</sup> Ave. South to 5330 at 15<sup>th</sup> Ave. South also lost sand from the 0 to -5 ft contour, but north of here the remaining stations were fairly stable on the lower beach. In general the dry-sand berm width here is still adequate and continues to provide storm damage protection and a recreational benefit. Station 5430 showed accretion in the profile from -5 to +5 ft from fall 2005 through 2007 and slight accretion in the upper beach and loss below 0 ft through 2008.

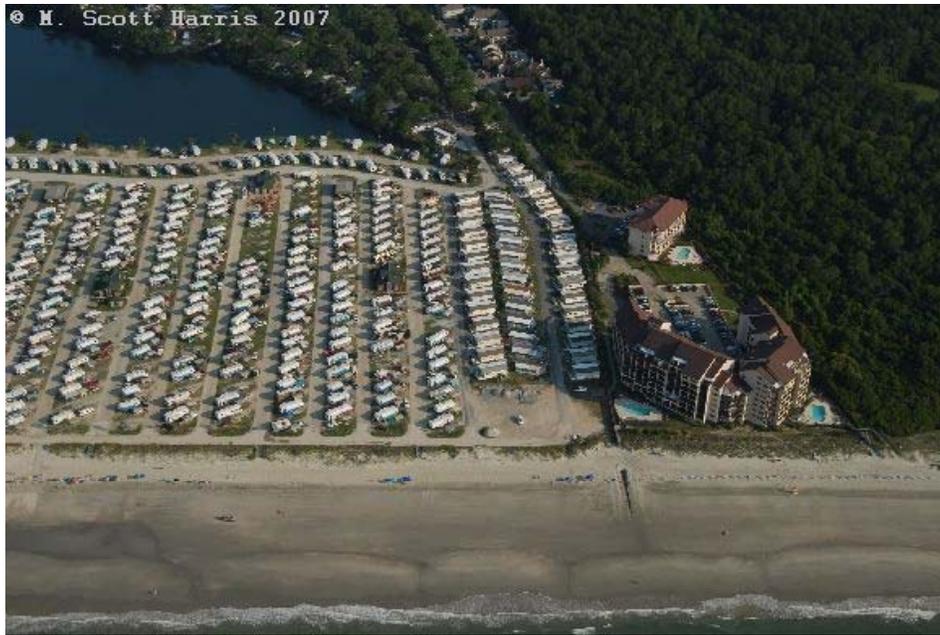
**Figure 44. Aerial photograph of campground, condominiums, and natural area near stations 5550 and 5560. (photo credit Scott Harris, June 2007)**

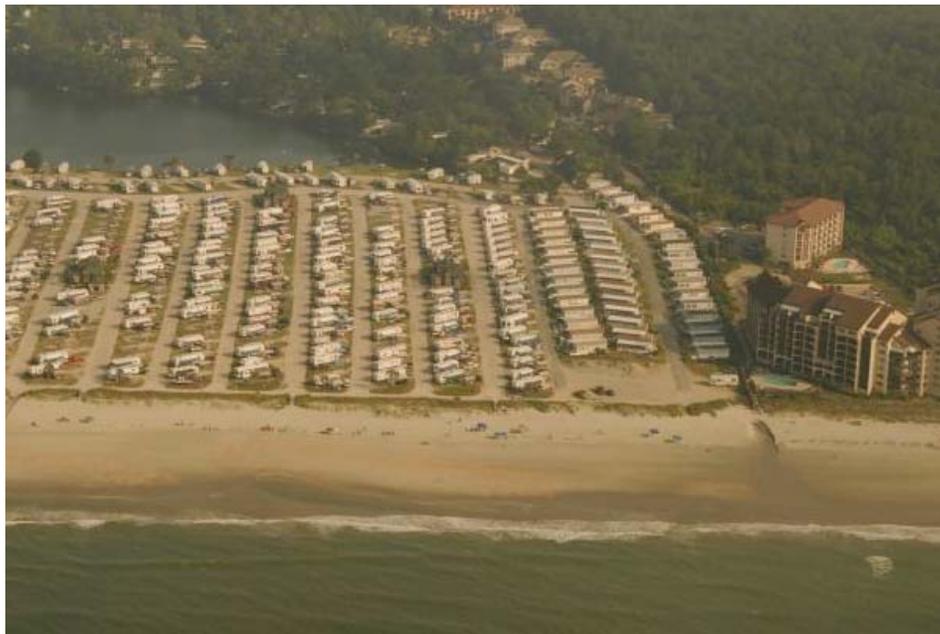
**Figure 45. Aerial photograph near stations 5550 and 5560. (photo credit Scott Harris and DHEC, June 25, 2008)**

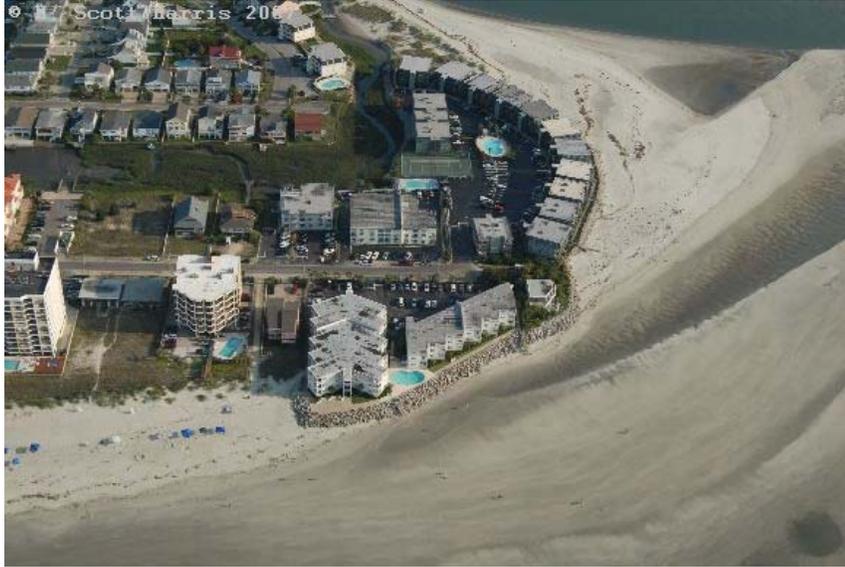
**Figure 49. The north end of Cherry Grove, where inlet processes make this region very dynamic. A new sand bar welds on to the shoreface here. (photo credit Scott Harris, June 2007)**

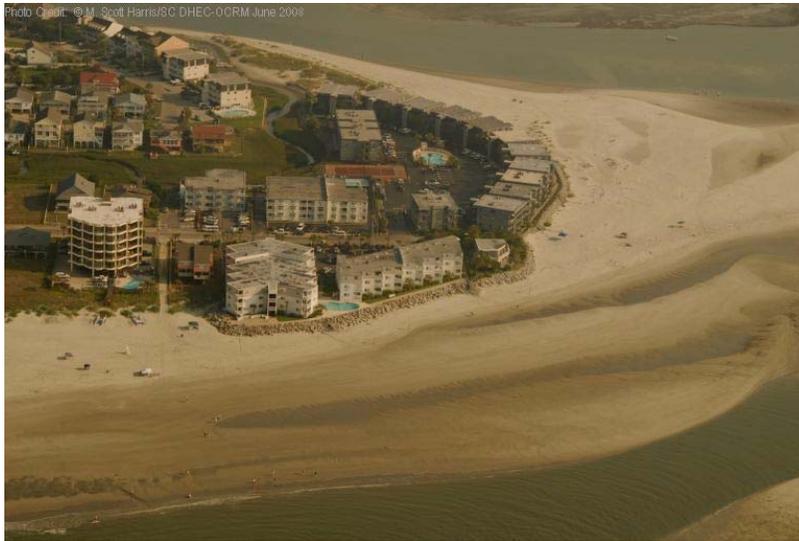
**Figure 50. The north end of Cherry Grove, showing the accumulation of bars in the nearshore where the channel cuts and fills. (photo credit Scott Harris and DHEC, June 2008)**
