**STAFF RECOMMENDATION AND REQUEST FOR PUBLIC HEARING TO INFORM THE  
FINAL AGENCY DECISION - WAVE DISSIPATION SYSTEM**

**Staff Recommendation and Request for Public Hearing to Inform  
the Final Agency Decision - Wave Dissipation System**

**November 2016**

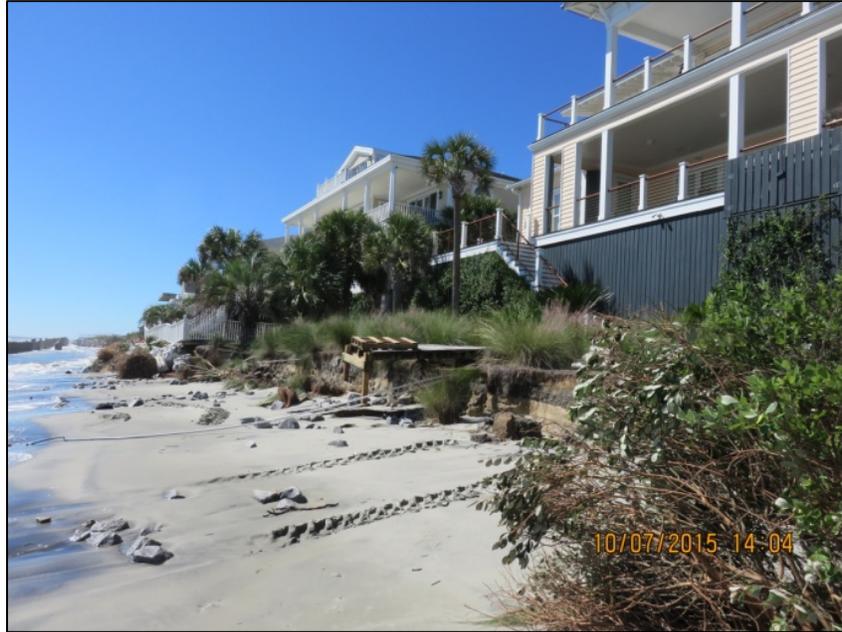
**Figure 2:** Scarp erosion landward of the Beachwood East WDS during storm conditions before the placement of emergency sandbags. This was approximately 1 month after the WDS was installed.

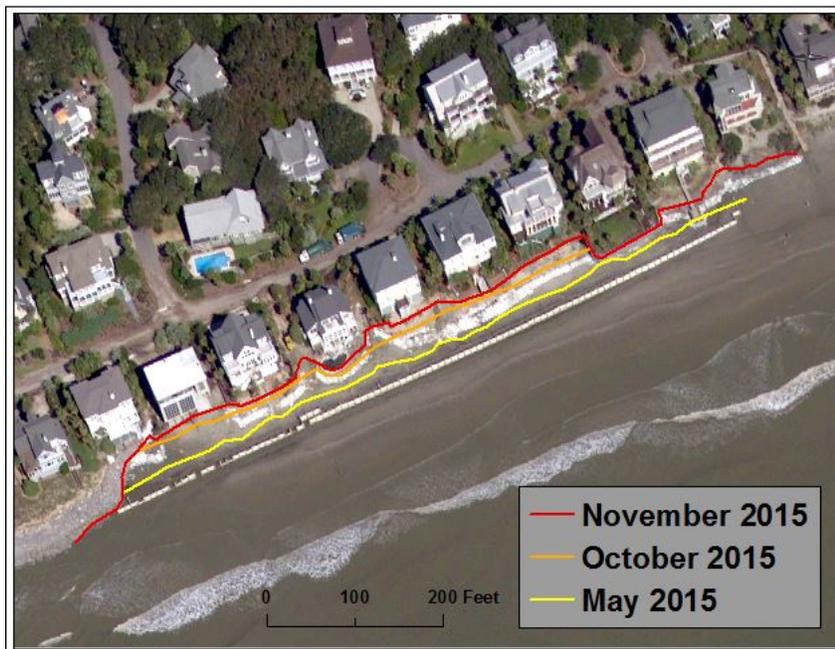
**Map 1:** Shows the landward movement of the scarp line position at Beachwood East after the WDS was installed.

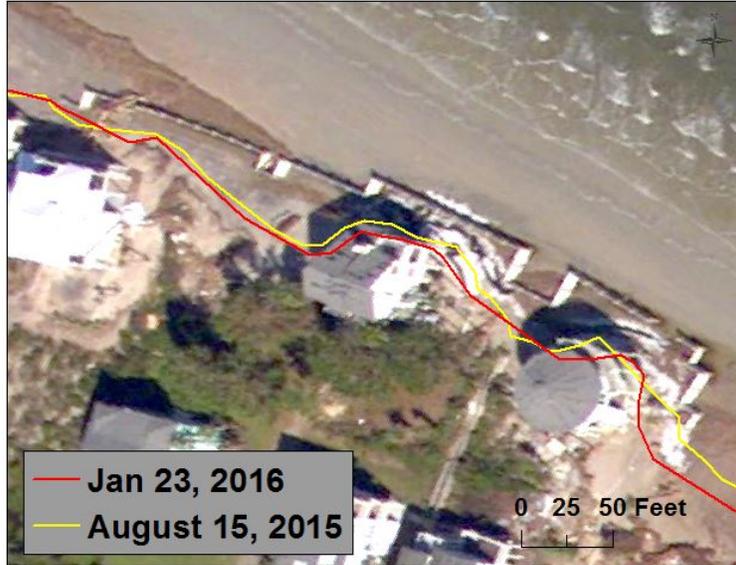
**Map 2:** Shows the landward movement of the scarp line position at Harbor Island after the WDS was installed.

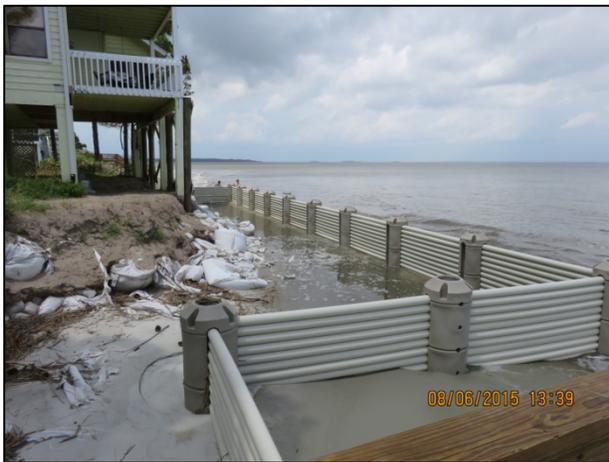
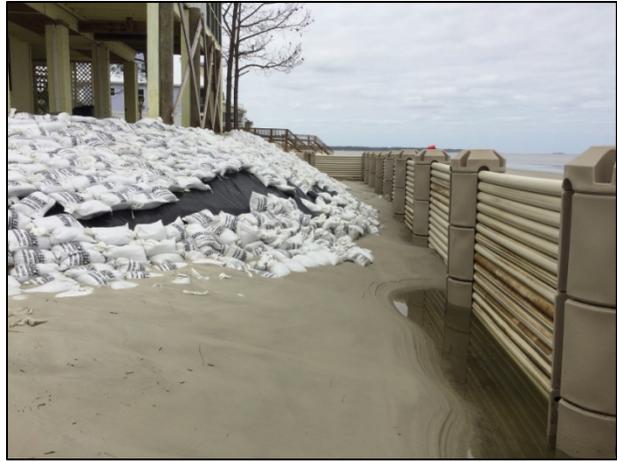
**Figure 3:** Harbor Island WDS location after WDS installation (left) and after new sandbags (right).

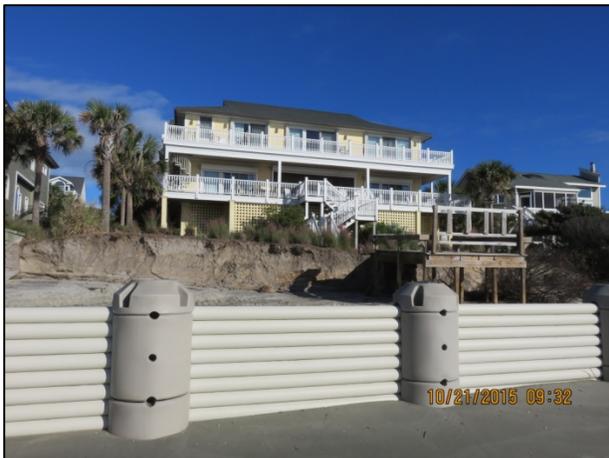
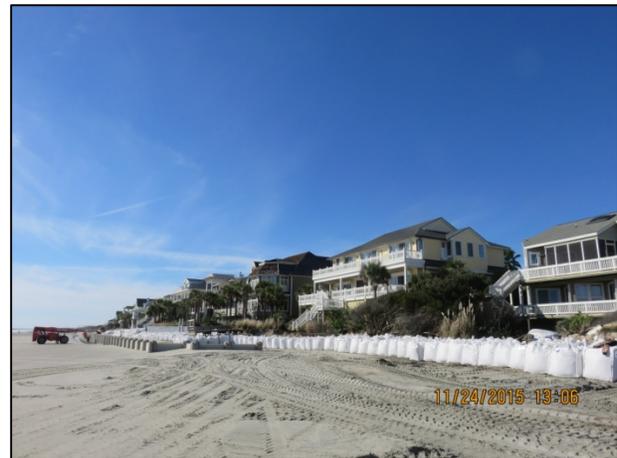
**Figure 4:** Beachwood East WDS location before (left) and after (right) sandbags.

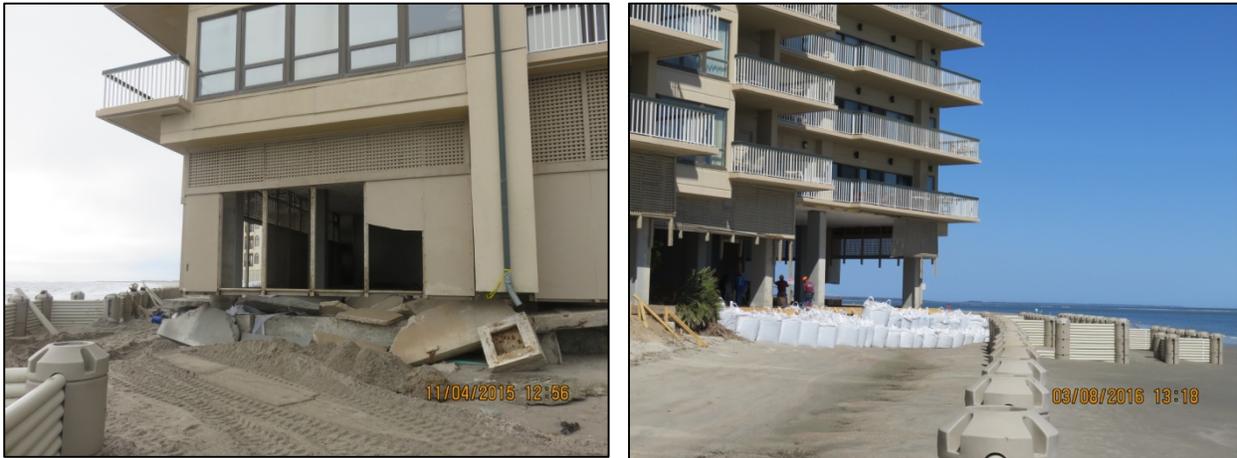
**Figure 5:** Ocean Club Villas WDS location before (left) and after (right) sandbags.

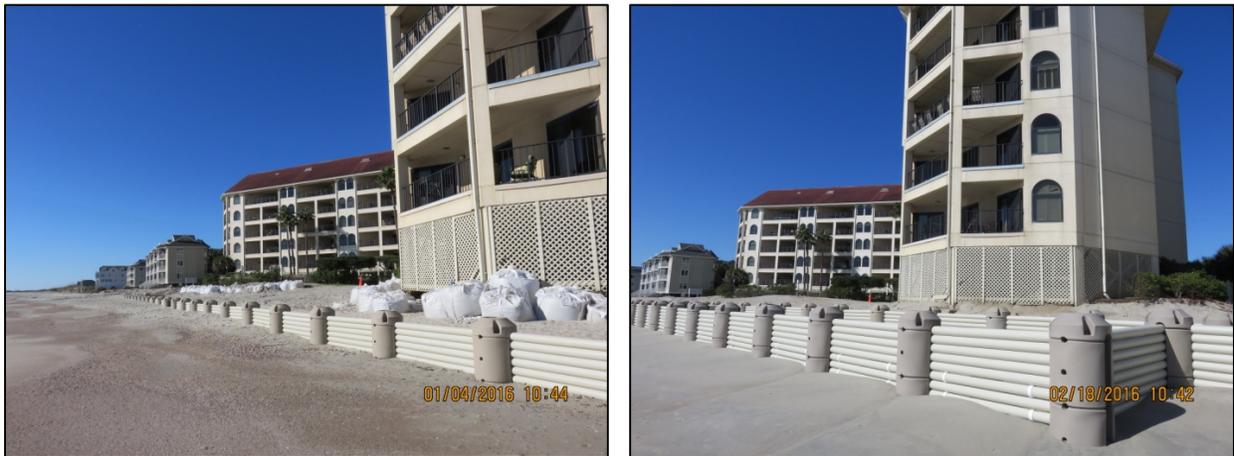
- The WDS did not maintain the scarp line or MHW positions. While the scarp line position did not change drastically during GEL’s study, which covered the time period between March and July 2016, the scarp eroded significantly at each WDS site after the structures were installed, but before GEL began their study (Figure 2). This earlier scarp line movement was documented in the data collected by The Citadel and mapped by DHEC – OCRM (Maps 1 and 2). This continued scarp erosion led to property owners requesting emergency sandbags for scarp protection at different times during the study at all four WDS locations. The sandbags at Harbor Island were already present prior to installation of the WDS at that location, but several renewals of the sandbag Emergency Orders were issued by DHEC-OCRM during the study to allow property owners to continue to protect their property from erosion (Figure 3). At Beachwood East, sandbags have been on the beach landward of the WDS since Fall of 2015 (Figure 4). At Ocean Club Villas, the sandbags were cut open after the broken slab beneath the building was repaired to allow the sand to be added landward of the WDS (Figure 5). The sandbags were subsequently removed from the site. At Seascape Villas, the sandbags were also cut open to allow the sand to be added landward of the WDS. The sandbags were cut open and removed after the second tier of the WDS was installed (Figure 6).

**Figure 6:** Seascape Villas WDS location before 2<sup>nd</sup> tier installed (left) and after 2<sup>nd</sup> tier installed (right).

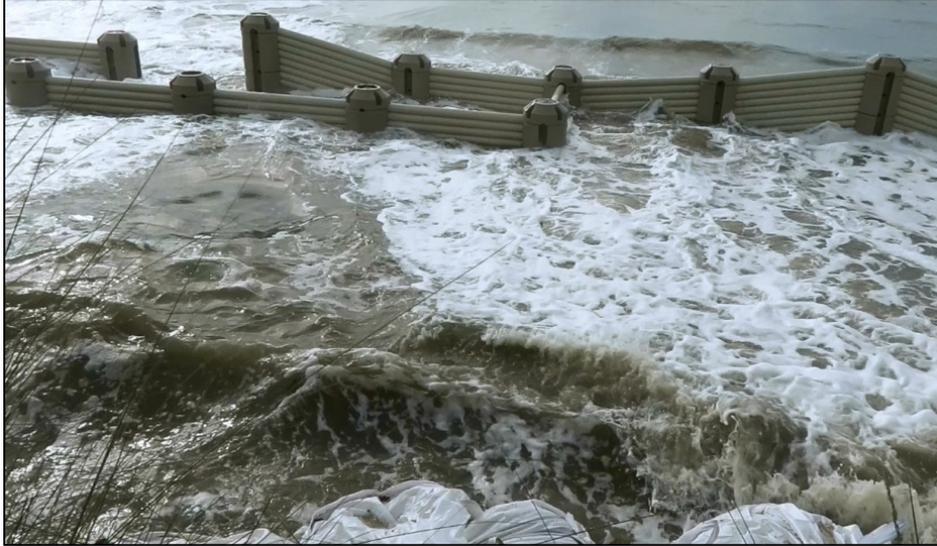
- DHEC-OCRM staff observed that the pooling of water on the landward side of the WDS allowed waves to re-form and break higher up on the beach, thus impacting the sandbags or eroding the scarp line (Figure 7).

**Figure 7:** Waves re-forming and breaking on the landward side of the Beachwood East WDS. Video screen-grab from September 29, 2015.

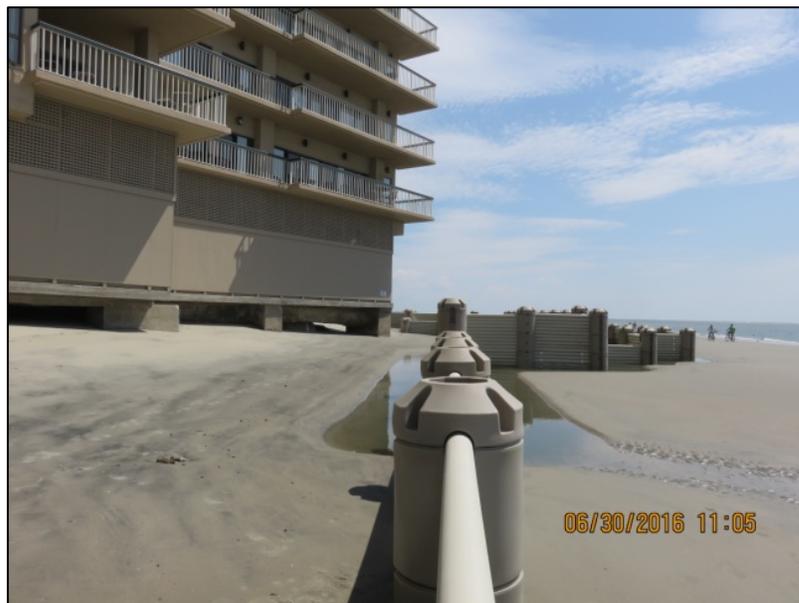
- When used as the sole erosion mitigation technique, the WDS does not hold the scarp line position or protect property landward of it. At Beachwood East and Harbor Island, sandbags were requested and employed by property owners for the duration of the study to stabilize the scarp line and protect their property. At Ocean Club, sandbags were deployed for part of the study. When sandbags were not present at that location, the three-walled system of the WDS was sufficient to break enough wave energy to minimize damage to the building. However, the parking slab beneath the building collapsed and had to be replaced, and the scarp continued to move landward beneath the building (Figure 8).

**Figure 8:** Continued erosion beneath Ocean Club Villas Building #1. Also note the scour (trenching) that is present on both sides of the WDS.

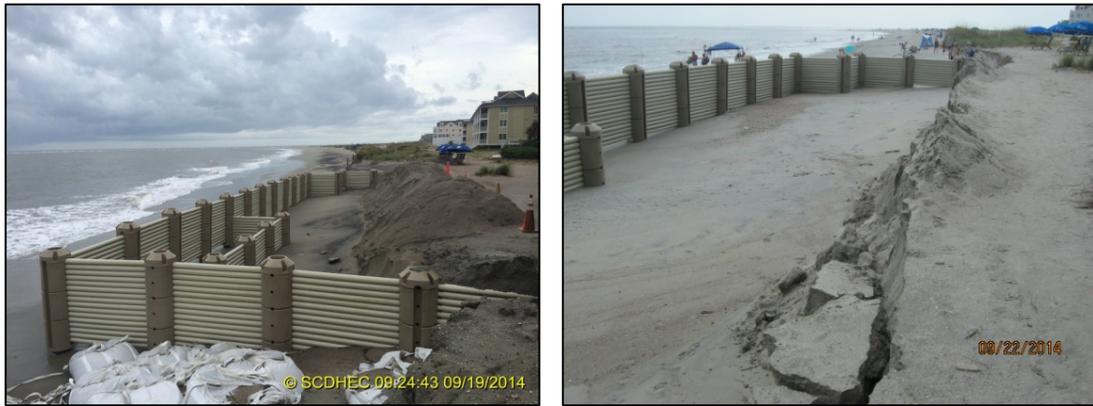
- The Citadel researchers requested to bulldoze sand on the landward side of the WDS at Beachwood East to build a dune. DHEC-OCRM denied the request for two reasons: 1.) Bulldozing the sand would have altered the study data. Beach profile data (elevations and scarp line positions) were collected monthly throughout the study by both The Citadel and by GEL to determine the effects of the WDS on the beach. Artificially altering the beach profile by bulldozing or minor renourishment would have resulted in an inconclusive study, 2.) During the first WDS study at Seascape Villas in 2014, The Citadel researchers bulldozed the sand behind that WDS installation without prior DHEC-OCRM authorization, and the piled up sand eroded away in a matter of days (Figure 11). Lowering the beach profile landward of the WDS by bulldozing allowed the waves to reach higher up the beach and erode the scarp line more quickly.

**Figure 11:** Sand that was scraped and piled up by The Citadel research team at Seascape Villas on September 19, 2014 (left), which had almost completely eroded by September 22, 2014 (right).

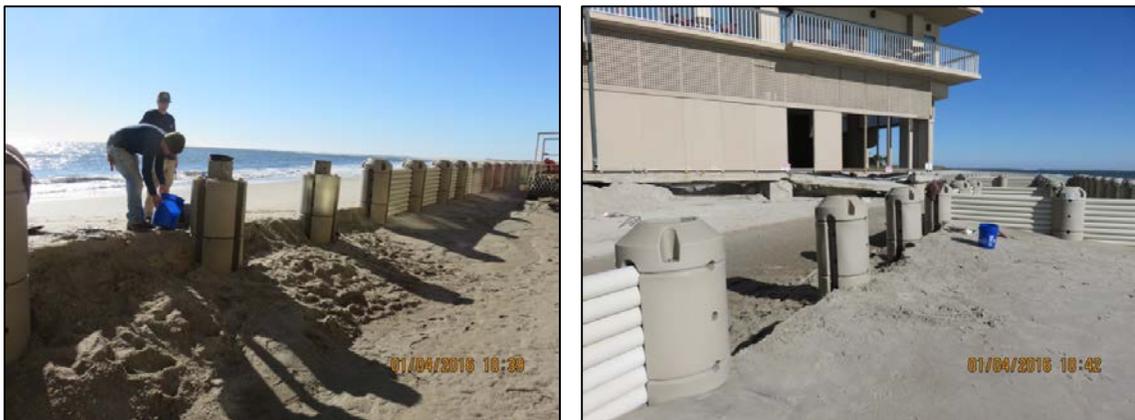
- Where the WDS is present during calm conditions, sand that is naturally moving landward (up the beach profile) becomes trapped on the seaward side of the WDS. This results in the need for spacers and periodic panel removal to allow the trapped sand to move to the landward side of the WDS (Figure 12). Limited sand is able to be pushed by waves and tides through the panels, but this sand would have moved up the beach profile naturally if the WDS were not obstructing it (Figure 13). Where the WDS is present during storm conditions, scour on both sides of the WDS allows more water to reach the scarp and erode it when the scarp is not protected by sandbags. Net accretion observed by GEL during their study at the WDS sites was always on the seaward side of the structure (not on the landward side). The WDS blocks the natural accretion of sand on the shoreline during calm conditions, and is ineffective without sandbags during storm conditions. Therefore, the WDS does not increase or retain sand on the landward side.

**Figure 12:** Horizontal panels removed at the Ocean Club WDS in January 2016 to allow sand that was trapped on the seaward side of the structure to continue moving to the landward side of the structure.

- Where the WDS is present during calm conditions, sand that is naturally moving landward (up the beach profile) becomes trapped on the seaward side of the WDS. This results in the need for spacers and periodic panel removal to allow the trapped sand to move to the landward side of the WDS (Figure 12). Limited sand is able to be pushed by waves and tides through the panels, but this sand would have moved up the beach profile naturally if the WDS were not obstructing it (Figure 13). Where the WDS is present during storm conditions, scour on both sides of the WDS allows more water to reach the scarp and erode it when the scarp is not protected by sandbags. Net accretion observed by GEL during their study at the WDS sites was always on the seaward side of the structure (not on the landward side). Since the WDS blocks the natural accretion of sand on the shoreline during calm conditions and is ineffective without sandbags during storm conditions, DHEC-OCRM finds that the WDS **does not satisfy** this qualification.

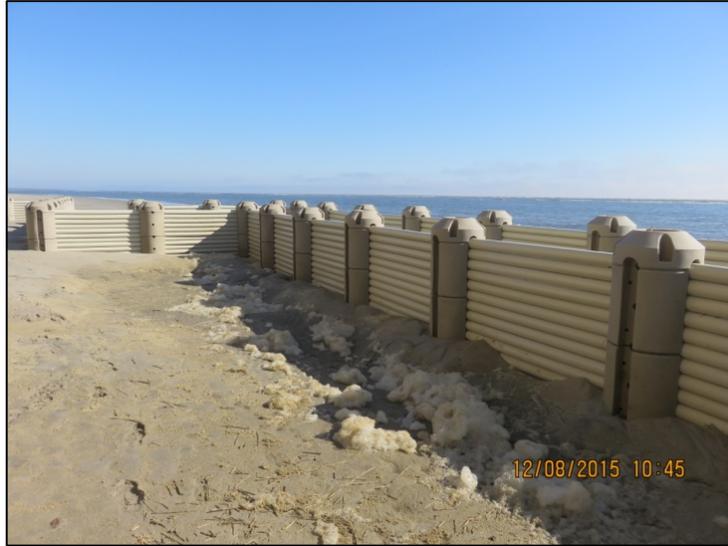
**Figure 13:** Small mounds of sand that have been able to move landward through the Ocean Club WDS in December 2015.

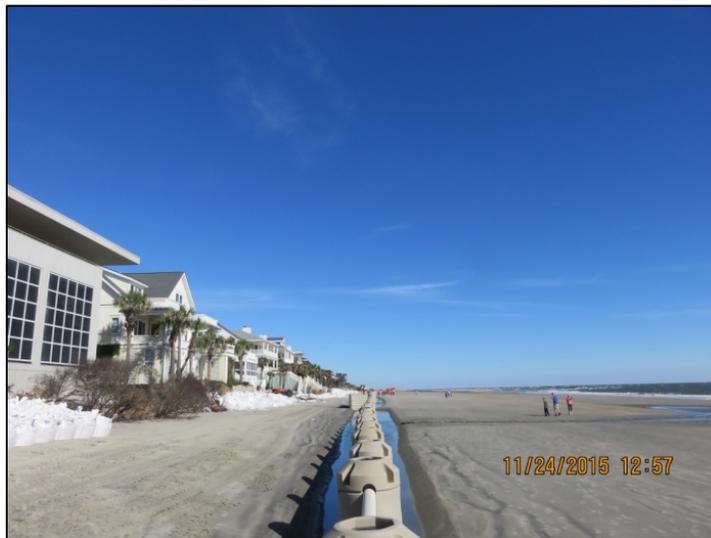
- DHEC – OCRM staff observed persistent trenching and scour at the base of the structures at all sites except Seascape Villas (Figures 14 and 15).
- Trenching and scour was photo documented at the following locations and dates.
  - Ocean Club in April and May of 2016.
  - Beachwood East in September, October, November, and December 2015 and February, April, May, and June 2016.
  - Harbor Island in July, August, September, October 2015, and March and April 2016.

**Figure 14:** Scour (trenching) on the seaward and landward sides of the Beachwood East WDS.

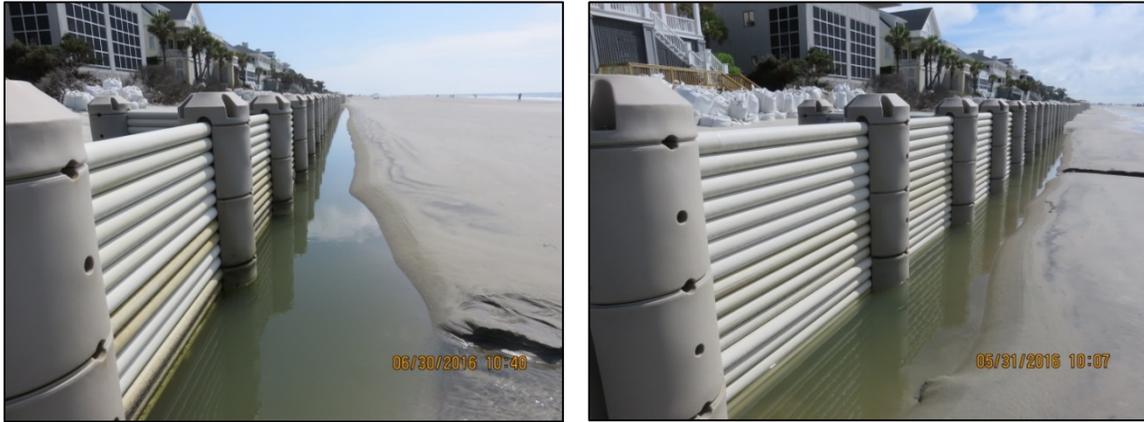
**Figure 15:** Example of persistent scour (trenching) at the Beachwood East WDS. Similar effects were seen throughout the study at all WDS sites except Seascape Villas.

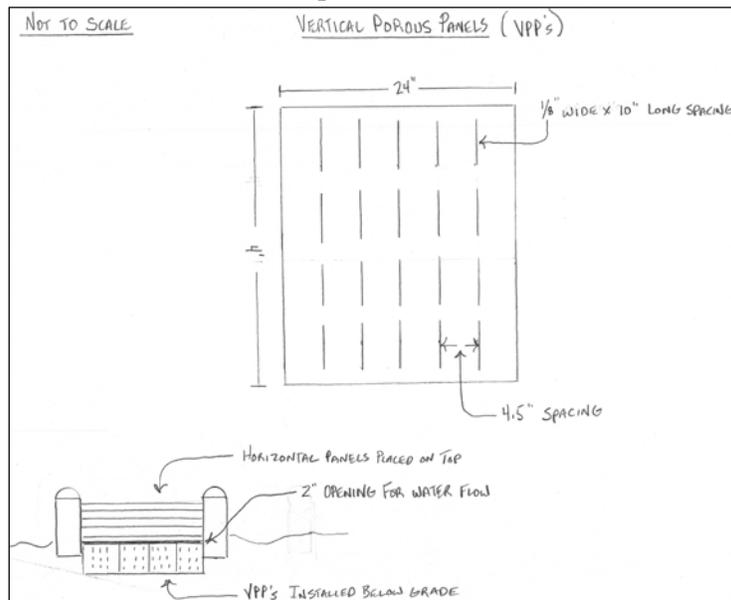
- The Citadel researchers installed “Vertical Porous Panels” (VPP’s) at certain locations at Ocean Club and Beachwood East below grade as a means to reduce trenching and scour. DHEC-OCRM approved a conceptual drawing of slotted VPP’s (Figure 16), but the installed VPP’s had very small drill holes instead of slots, resulting in a sheet pile structure below grade with minimal porosity (Figure 17). Since the installed panels did not match the approved panel, DHEC-OCRM informed The Citadel researchers that those VPP’s could not be installed at additional locations. DHEC-OCRM informed The Citadel researchers that the installed VPP’s could remain in place due to the physical alterations to the beach that would occur if they were dug up and removed. After some VPP’s were dislodged by wave action (Figure 18), The Citadel researchers voluntarily removed the VPP’s that were still in place.

**Figure 16:** Conceptual drawing of Vertical Porous Panels that was submitted by The Citadel research team and approved for use in the study by DHEC-OCRM. Each vertical slot was intended to be 1/8” wide and 10” long.

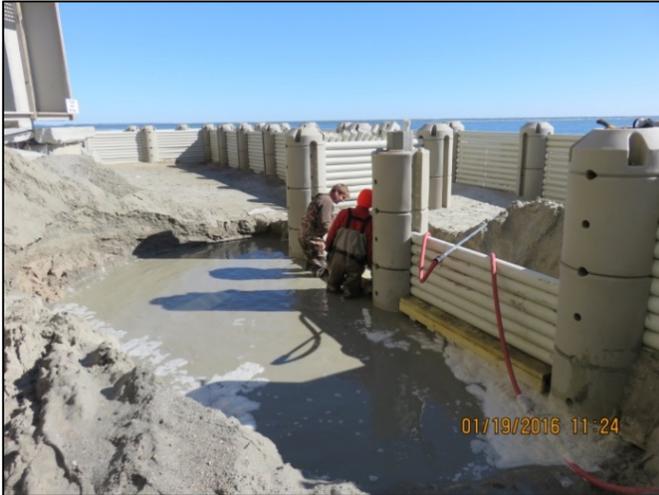
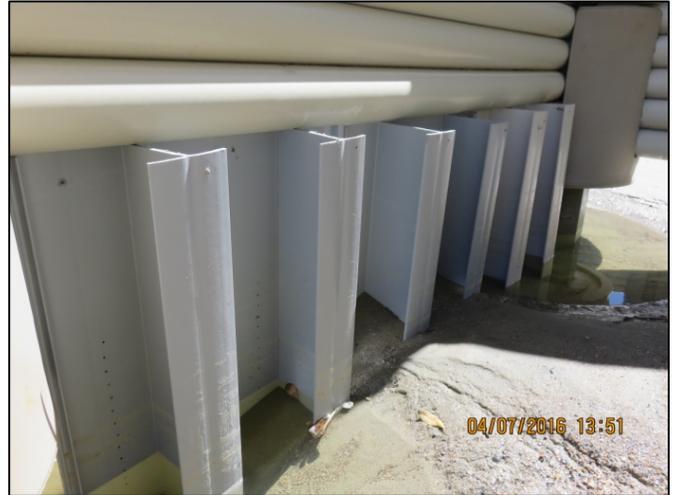
**Figure 17:** The actual Vertical Porous Panels that were installed at the Ocean Club WDS (left). Note that very small drill holes were used instead of slots, resulting in a VPP with minimal porosity (right).

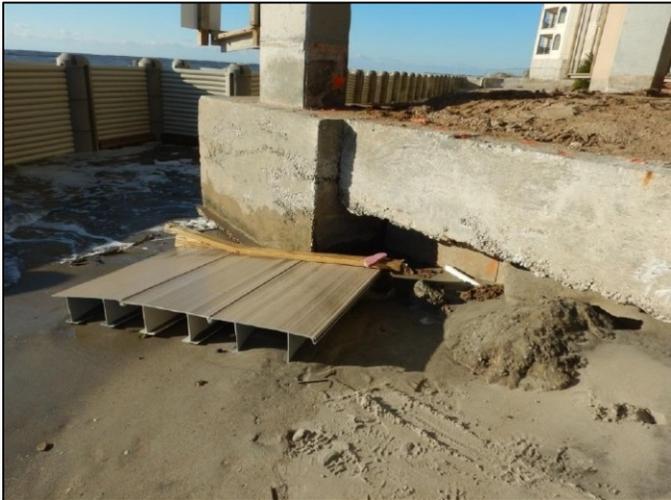
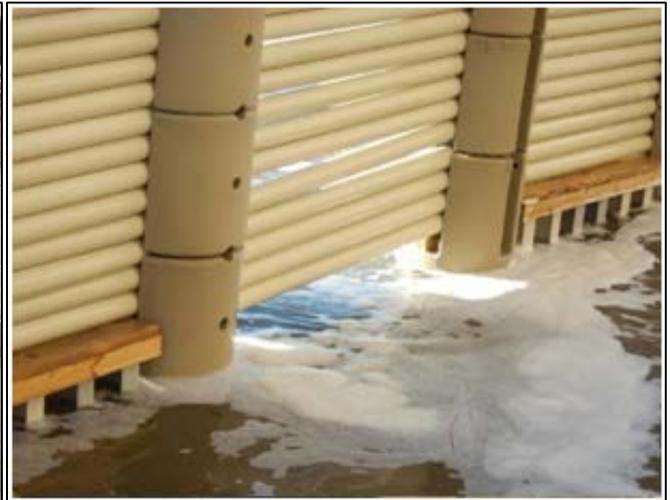
**Figure 18:** A Vertical Porous Panel that was dislodged by waves at the Ocean Club WDS in February 2016. Photo was taken by Stantec.

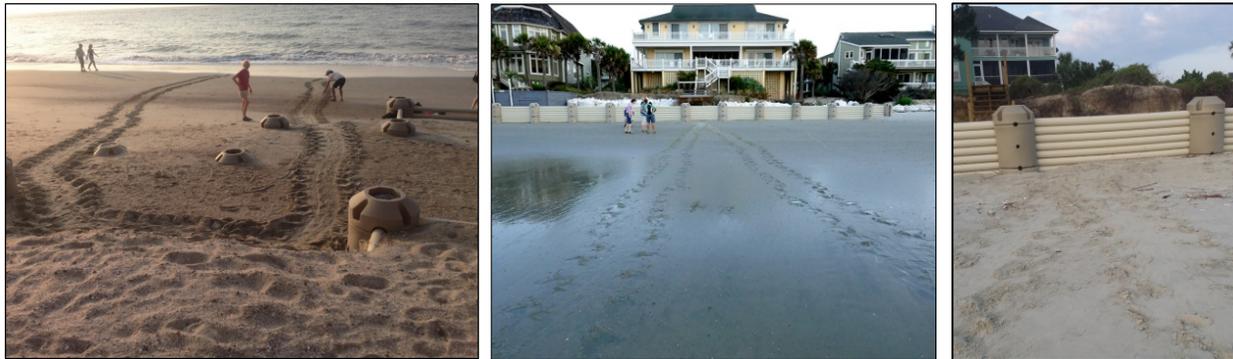
- Impacts to flora are undetermined, but data suggests that continued erosion of the scarp line landward of the WDS and increased erosion rates immediately adjacent to the WDS structure could impact flora in areas where dune vegetation is present.
- Nesting sea turtles interacted with the WDS twice at Ocean Club, once at Beachwood East, and four times at Harbor Island during the study period. In all cases, based on the tracks left in the sand, the sea turtles bumped into the WDS and eventually returned to the ocean without laying their eggs (Figure 19).

**Figure 19:** Examples of nesting sea turtle interactions with the WDS at Ocean Club (left), Beachwood East (middle), and Harbor Island (right).

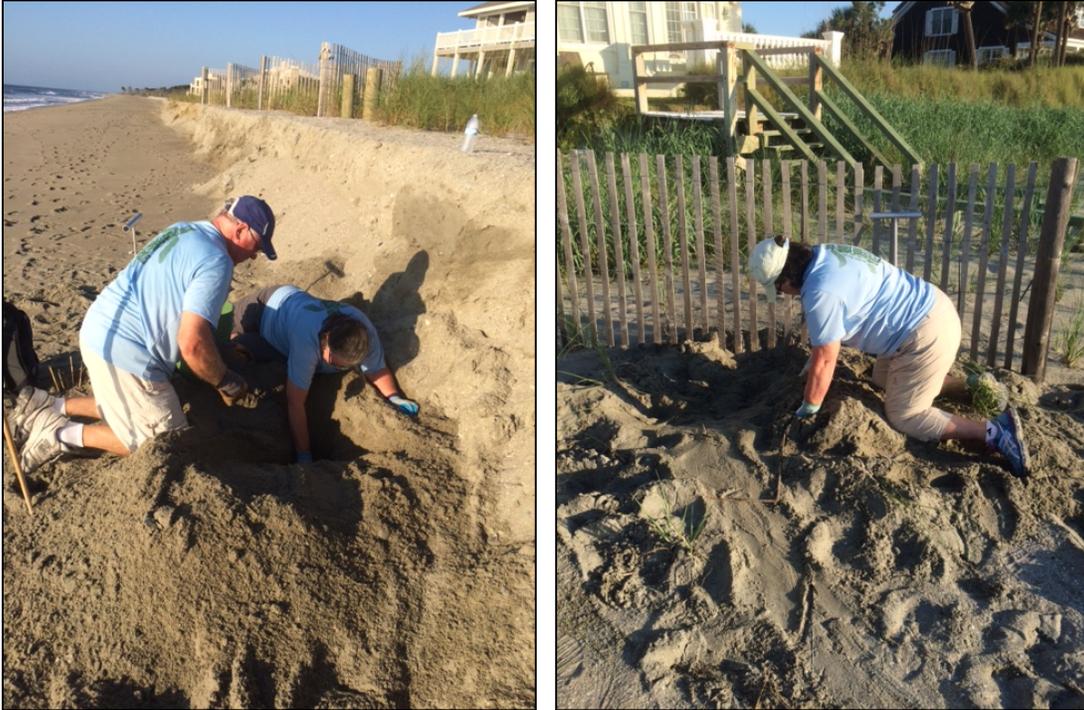
- It can be debated whether these sea turtle interactions with the WDS were “false crawls,” where the turtle would not have laid her eggs regardless of the presence of the WDS, or if the WDS interrupted a nesting attempt. It has been stated that nesting sea turtles are not negatively impacted by the WDS because the shoreline landward of the structures is heavily eroded and not conducive to sea turtle nesting. However, DHEC-OCRM has photographic evidence of sea turtle nesting in less than optimal areas, including at the base of erosional scarps (Figure 20). When a sea turtle nest is laid in an area with little

chance for successful hatching, Nest Protection Project Leaders and volunteers (which are active on Isle of Palms and Harbor Island) relocate the eggs to a more ideal location along the shoreline. The sea turtle interactions that occurred at the WDS may have been false crawls or they may have been legitimate nesting attempts. Therefore, regarding impacts to fauna, the WDS presents a potential harm associated with continued nesting attempts of sea turtles.

**Figure 20:** Sea turtle nests that were laid in less-than-ideal locations in areas without a WDS. These are nests on Debidue Island, SC.

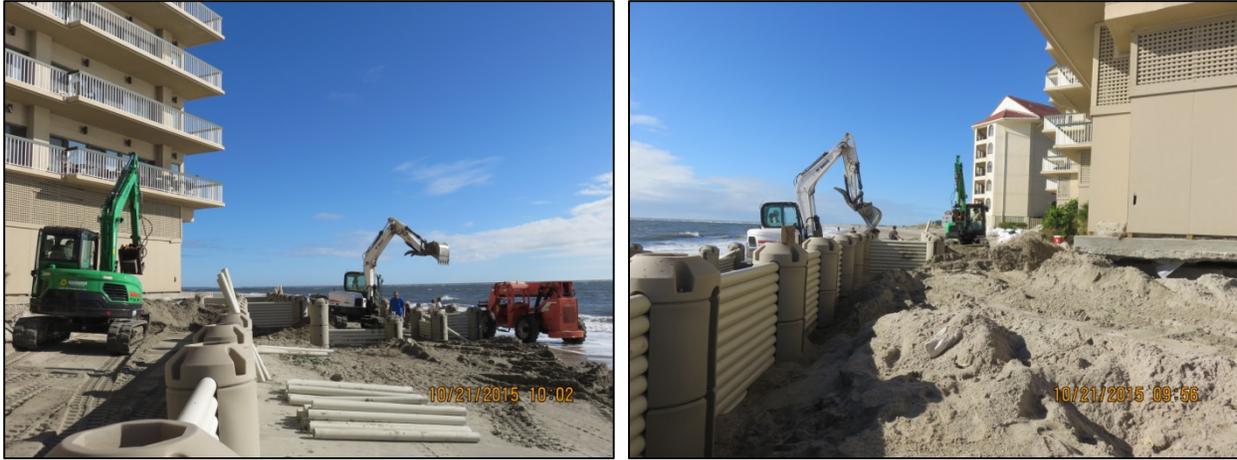
- Periodic Excavations: The WDS can be adjusted after initial deployment by lowering the pilings, lowering or raising the panels, adding spacers between panels, or temporarily removing the panels altogether. All of these adjustments were requested by The Citadel researchers and approved by DHEC-OCRM during the study period. These periodic excavations result in temporary impacts to the beach (Figure 21).

**Figure 21:** Adjustments to the Ocean Club WDS being made by The Citadel research team after Hurricane Joaquin in October 2015.

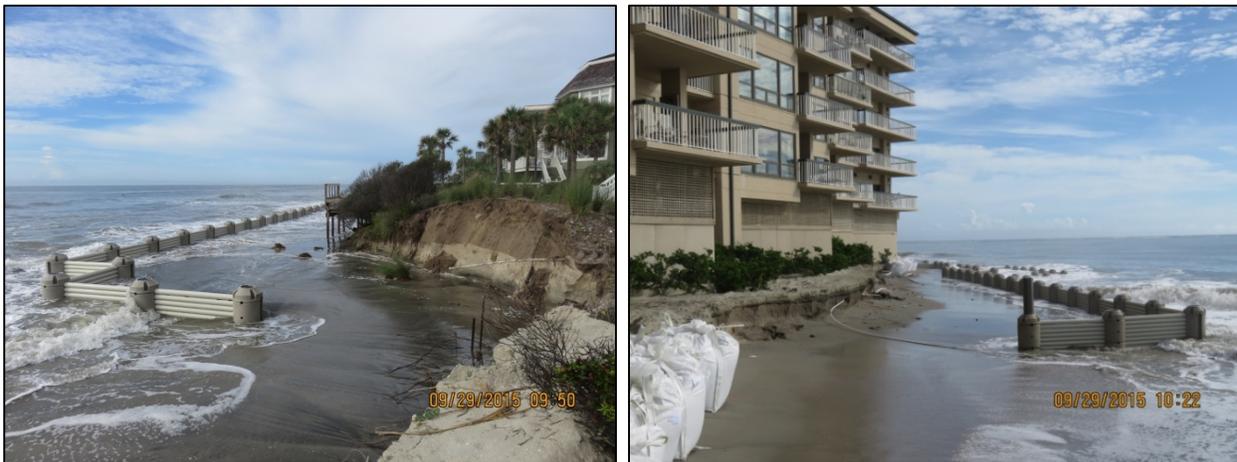
- Adjacent properties: The WDS does not prevent erosion of the shoreline on the “down-coast” side of the structure. In fact, where the WDS terminates, increased erosion was observed on unprotected properties immediately adjacent to the WDS (Figure 22).

**Figure 22:** Erosion at the northeastern end of the Beachwood East WDS (left) and the southwestern end of the Ocean Club WDS (right).
