**RE: Corrective Action Plan Results  
King Tract – Southern Mine GP1-002089  
Portion of TMS #625-00-00-007  
Awendaw, Charleston County, South Carolina**

Attachments: Photo documentation of Implementation of Corrective Action Plan

**Corrective Action Plan Photos**  
**King Tract – Southern Mine General Permit Area**  
**Portion of TMS #625-00-007**  
**Awendaw, Charleston County, South Carolina**

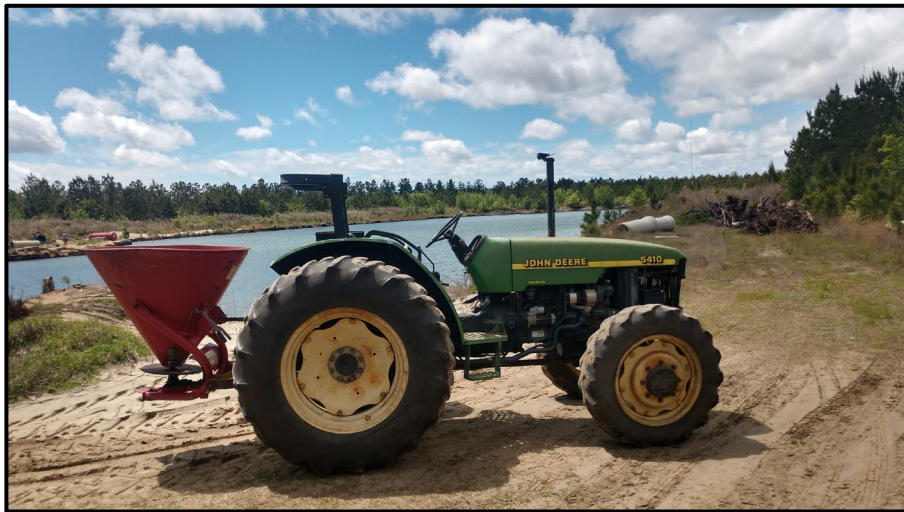
Photo 1: Tractor and Spreader utilized for application of Lime (04/20/20).

Prior to the site augmentation, an initial pH sample was collected from the existing pit with a result of 4.69 pH. Site augmentation was then implemented by the application of the lime to the above referenced areas via a tractor with a PTO-driven broadcast spreader. Upon completion of the lime application and a period of settling another pH sample was collected from the existing pit with a result of 7.46 pH which is within the acceptable range specified in the prior issued pH violation(s). Attached is photograph documentation of the application implementation as well as the sampling results.

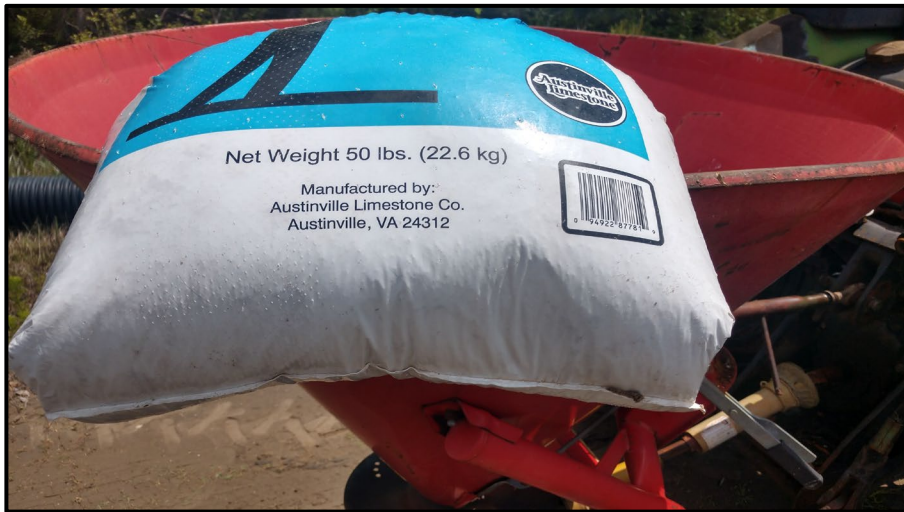
Photo 2: View of packaged Lime that was applied to GP Mine area side slopes and surface water perimeter (04/20/20).

- lime treatment of the existing GP mine area (direct treatment to surface water)
- lime treatment of the existing sediment retention basin (direct treatment to surface water)
- broadcast lime treatment to the bank of existing GP mine area

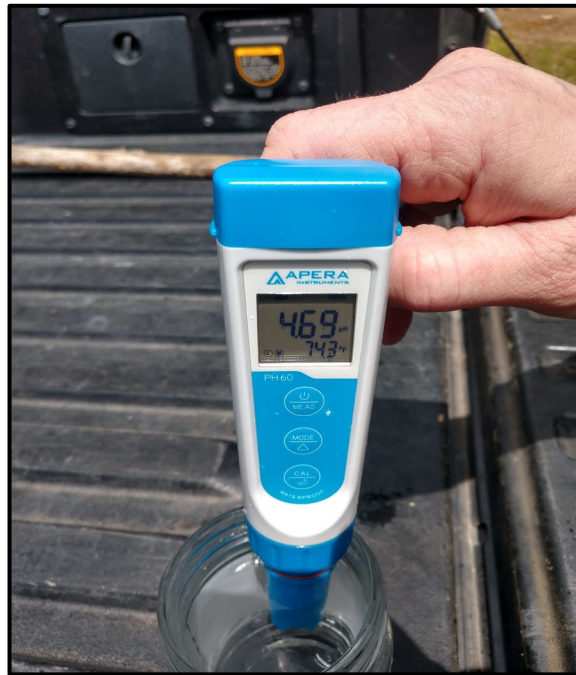
Photo 3: Pre-application of Lime pH Sample results from pit (04/20/20).

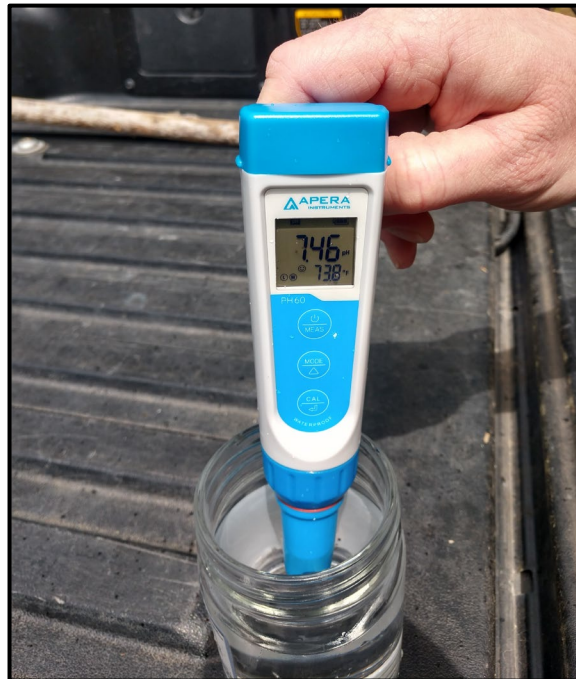
Photo 4: Post-application of Lime pH Sample results from pit (04/20/20).
